APPENDIX A
Area A Manhole Inspection Reports

Project Name: Trumbull 9/9 MANHOLE INSPECTION REPORTSubsystem Name/No. 5Manhole ID No. 5337Rating System (NASSCO)

Trumbull, CTPROJECT NO.: 12051 DDATE: 8/30/2011WEATHER: SunnyTIME: 3:16 pmINSPECTOR: mm, nke

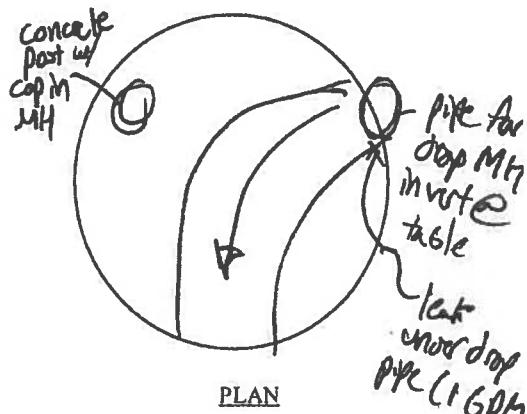
COMMENTS (REQUIRED): • lots of flow SECTION
• Crack on table

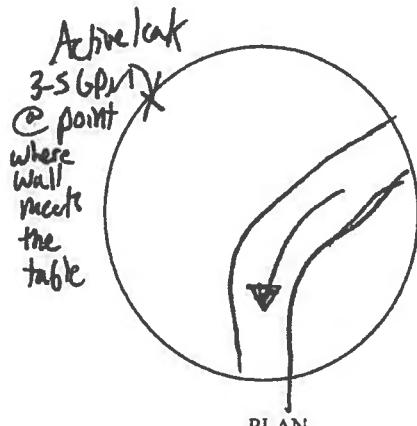
COMMENTS (REQUIRED): • 1 Active leak (3-56PM)

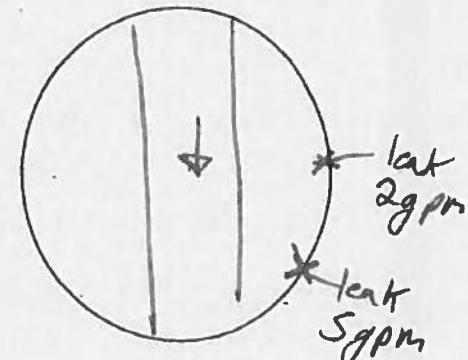
COMMENTS (REQUIRED): * 2 leaks @ 2.5 gpm *

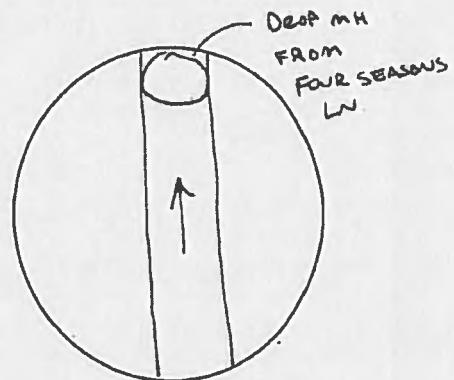
COMMENTS (REQUIRED): LEAKING AT TABLE CONNECTING
TO THE WALL. EVIDENCE OF LEAKAGE AT EGRESS. SECTION

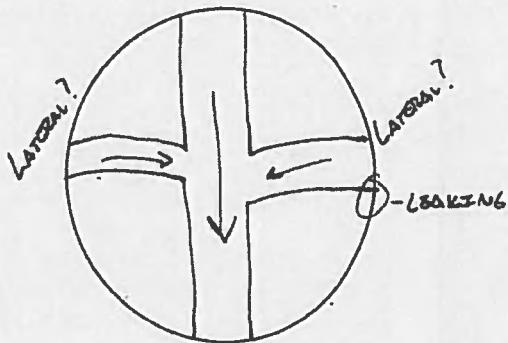
COMMENTS (REQUIRED): LEAKING LATERAL

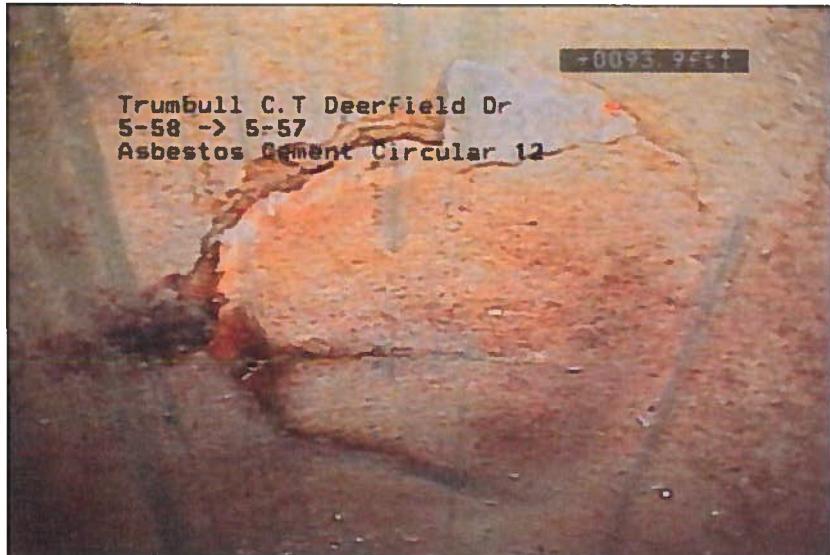
Photo: 232_233_1281_A.JPG, VCR No.: disc #22
93.9FT, Broken, at 12 o'clock, within 8 inches of joint: NO

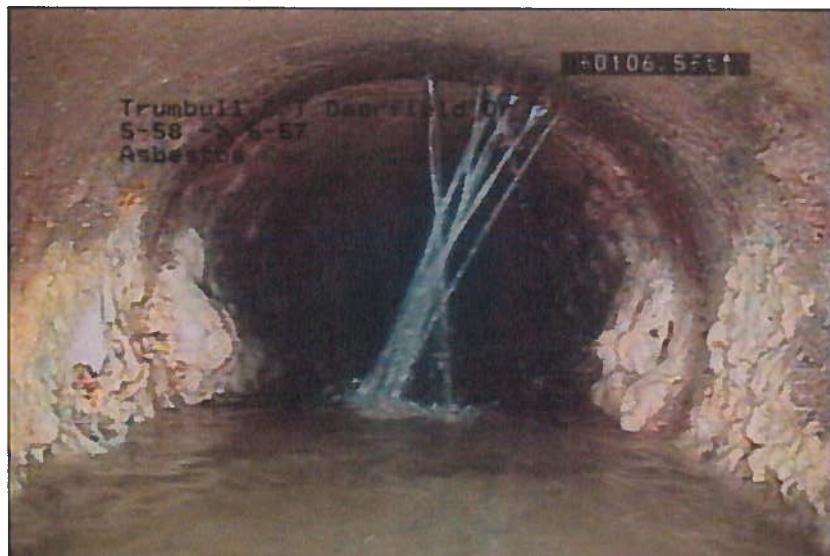
Photo: 232_233_1282_A.JPG, VCR No.: disc #22
106.5FT, Infiltration Gusher, from 12 to 01 o'clock, within 8 inches of joint: YES

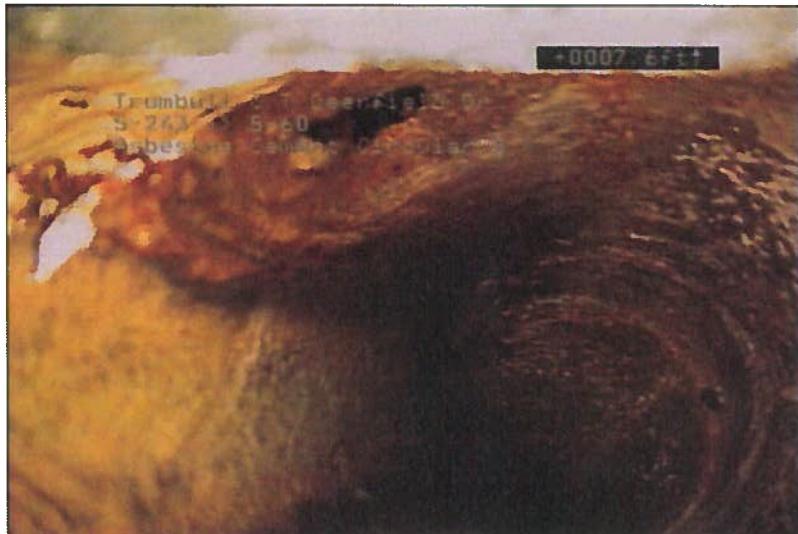
Photo: 114_115_739_A.JPG, VCR No.: disc #13
7.6FT, Tap Factory Made Defective, at 10 o'clock, 6", within 8 inches of joint: NO

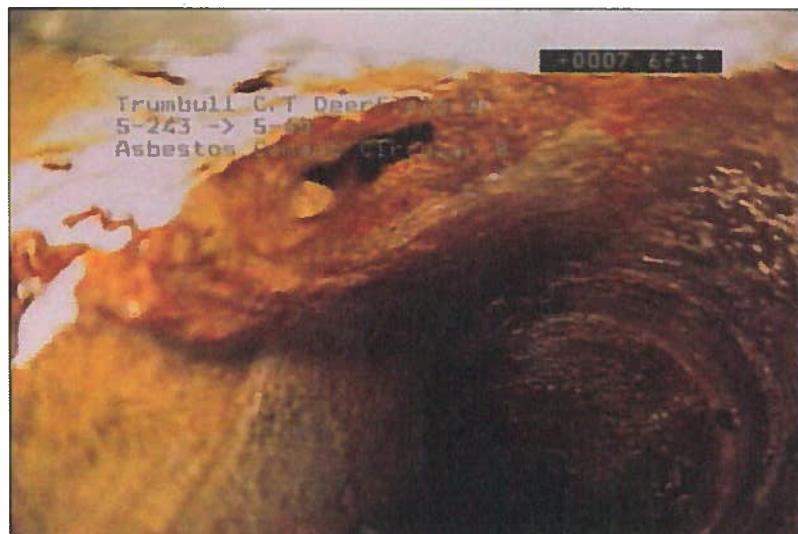
Photo: 114_115_741_A.JPG, VCR No.: disc #13
7.6FT, Infiltration Runner, at 10 o'clock, within 8 inches of joint: NO

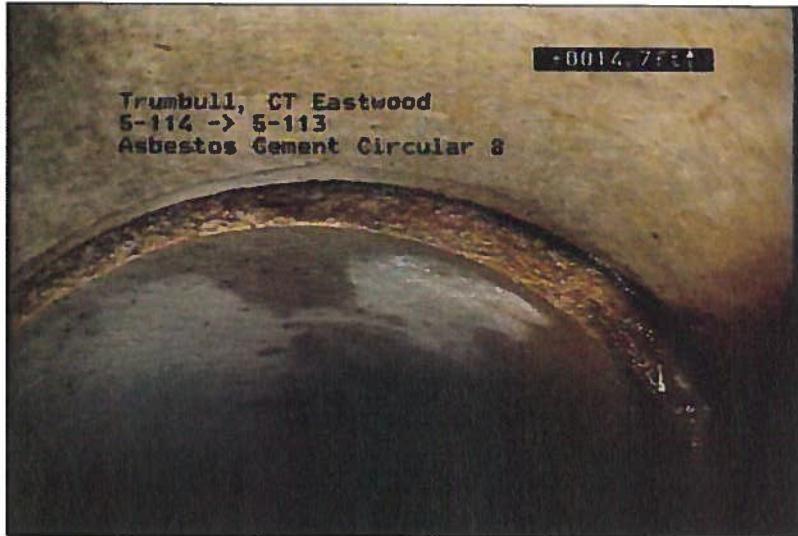
Photo: 14_15_105_A.jpg, VCR No.: Tape 1
14.7FT, Infiltration Gusher, from 03 to 05 o'clock, within 8 inches of
joint: YES

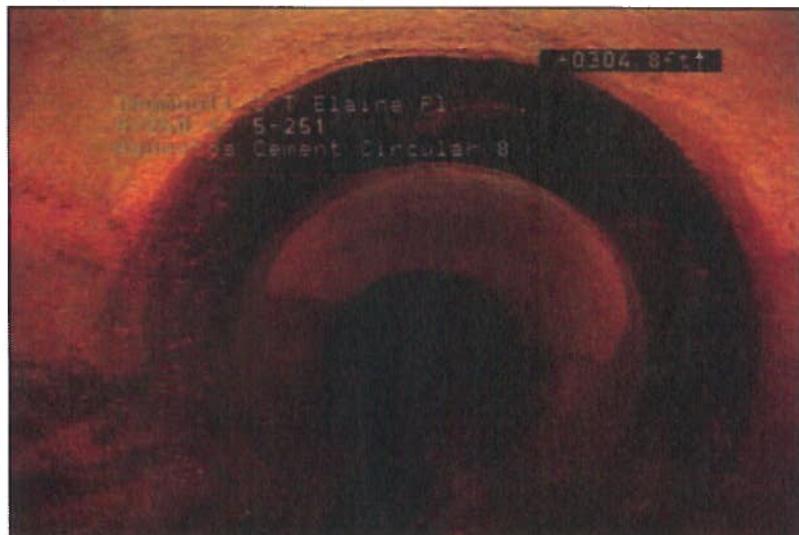
Photo: 118_119_769_A.JPG, VCR No.: disc #13
 304.8FT, Infiltration Weeper, from 12 to 12 o'clock, within 8 inches of joint: YES

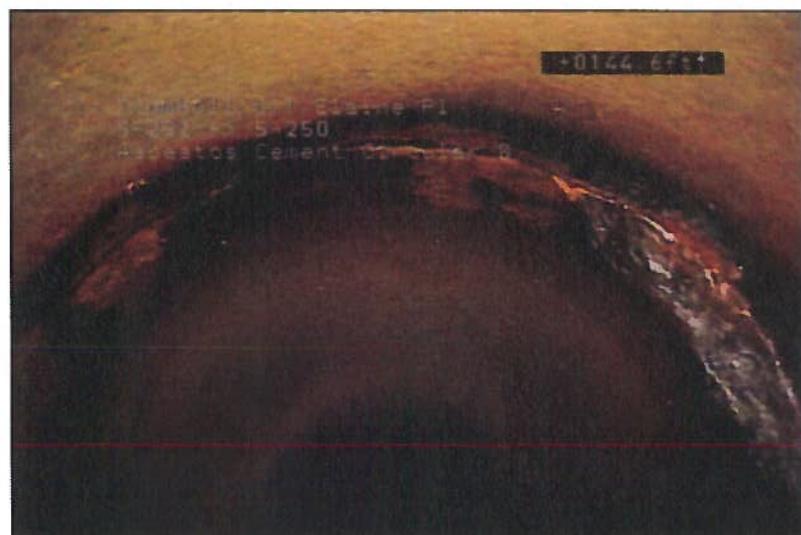
Photo: 117_118_758_A.JPG, VCR No.: disc #13
144.4FT, Infiltration Gusher, from 12 to 12 o'clock, within 8 inches of
joint: NO

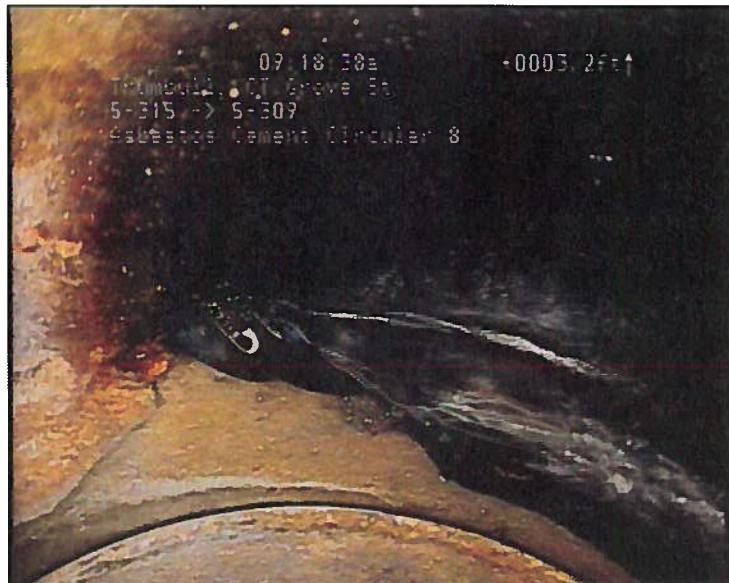
Photo: 73_74_520_A.JPG, VCR No.: Tape #4
3.2FT, Infiltration Gusher, at 02 o'clock, within 8 inches of joint: YES

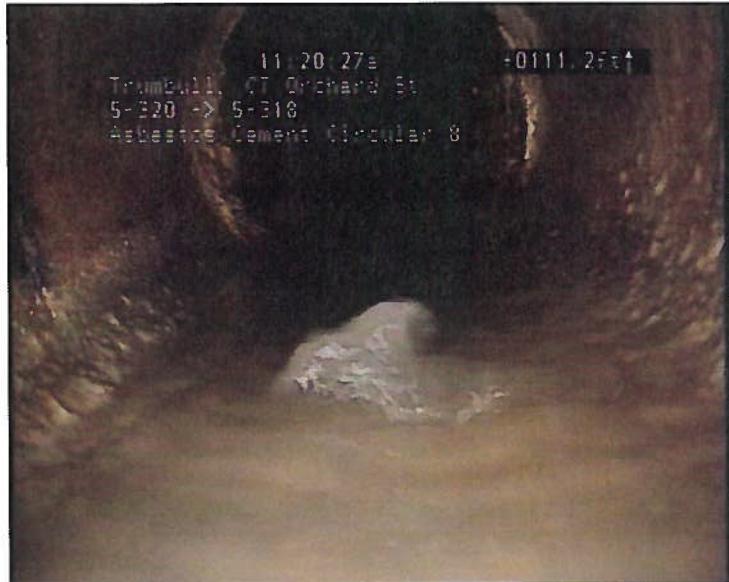
Photo: 79_80_558_A.JPG, VCR No.: Tape #5
111.2FT, Infiltration Gusher, at 06 o'clock, within 8 inches of joint: NO

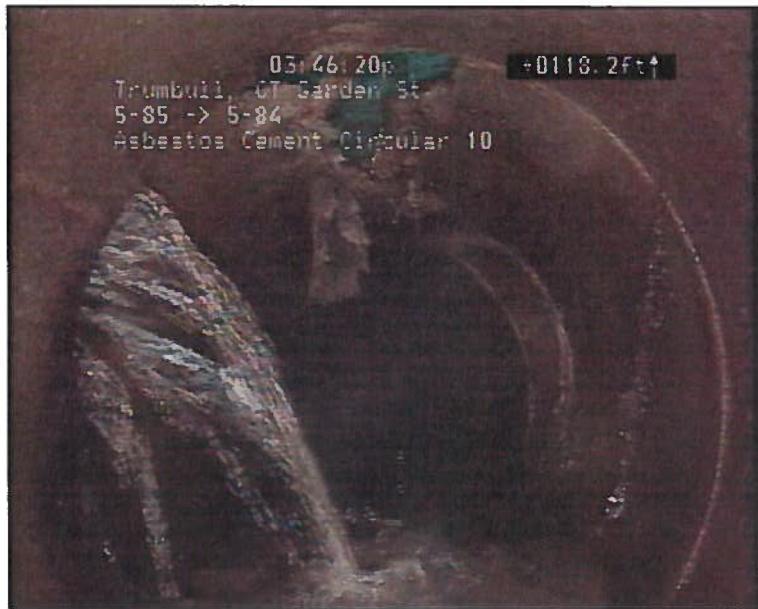
Photo: 118_119_790_A.JPG, VCR No.: Tape #6
118.2FT, Infiltration Gusher, from 08 to 11 o'clock, within 8 inches of joint: YES

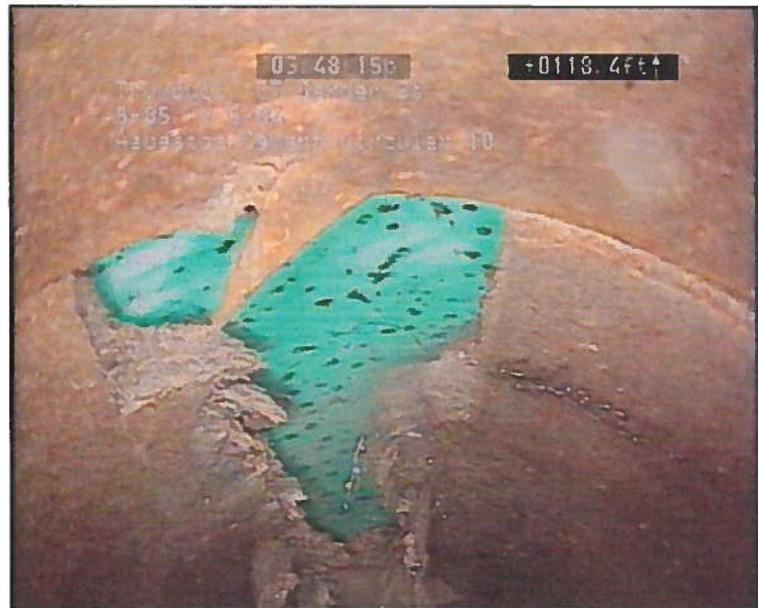
Photo: 118_119_791_A.JPG, VCR No.: Tape #6
118.2FT, Repair Patch, at 12 o'clock, within 8 inches of joint: YES

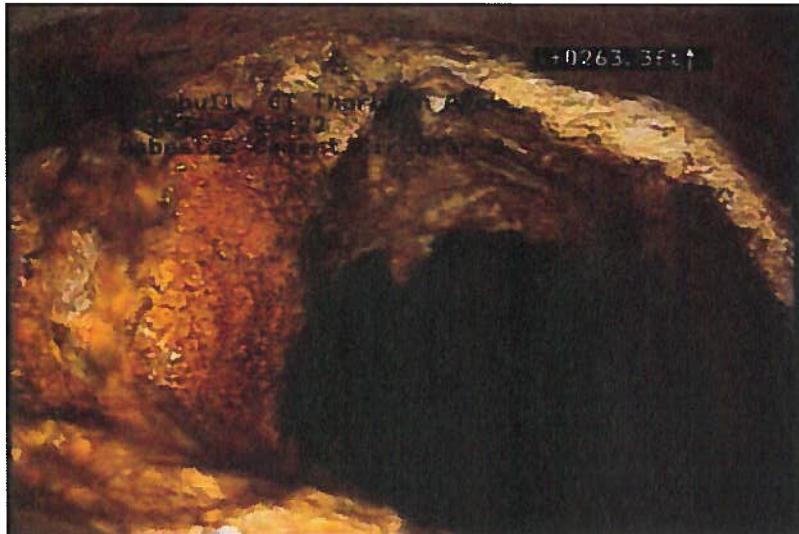
Photo: 10_11_79_A.jpg, VCR No.: Tape 1
263.6FT, Infiltration Gusher, at 10 o'clock, within 8 inches of joint: NO

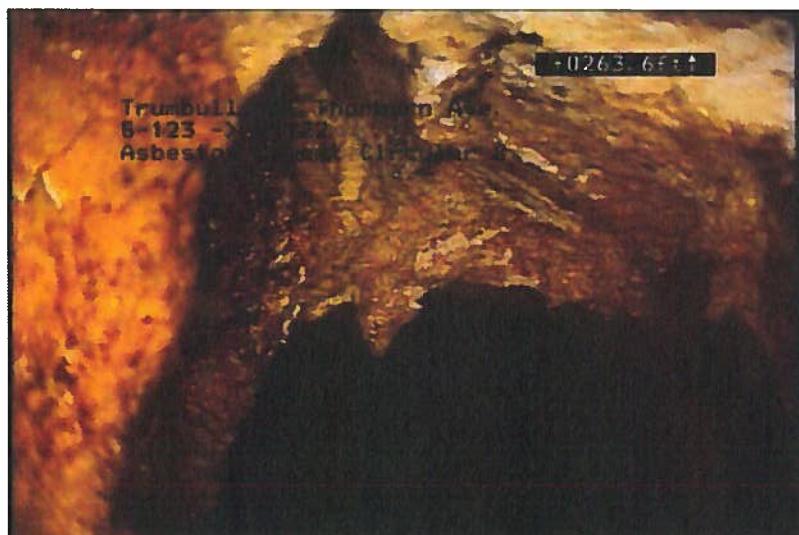
Photo: 10_11_80_A.jpg, VCR No.: Tape 1
263.6FT, Deposits Attached Encrustation, 30 % of Cross Sectional Area, at 10 o'clock, Within 8 inches of joint: NO

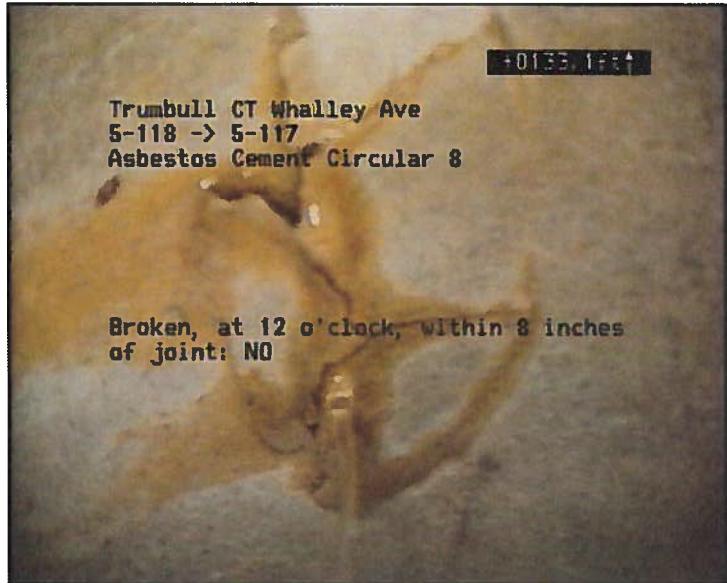
Photo: 1_1_6_A.JPG, VCR No.: Tape 1
133.1FT, Broken, at 12 o'clock, within 8 inches of joint: NO

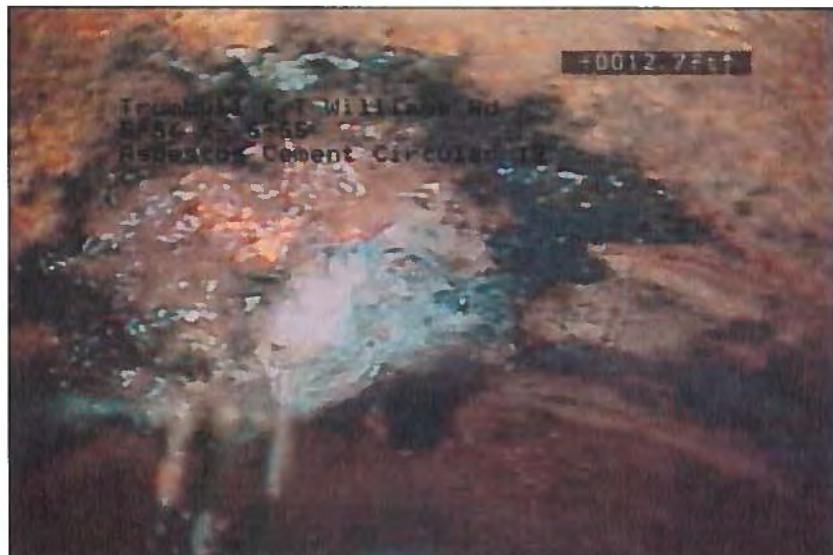
Photo: 359_360_2137_A.jpg, VCR No.: disc #21
12.7FT, Infiltration Runner, at 11 o'clock, within 8 inches of joint: YES

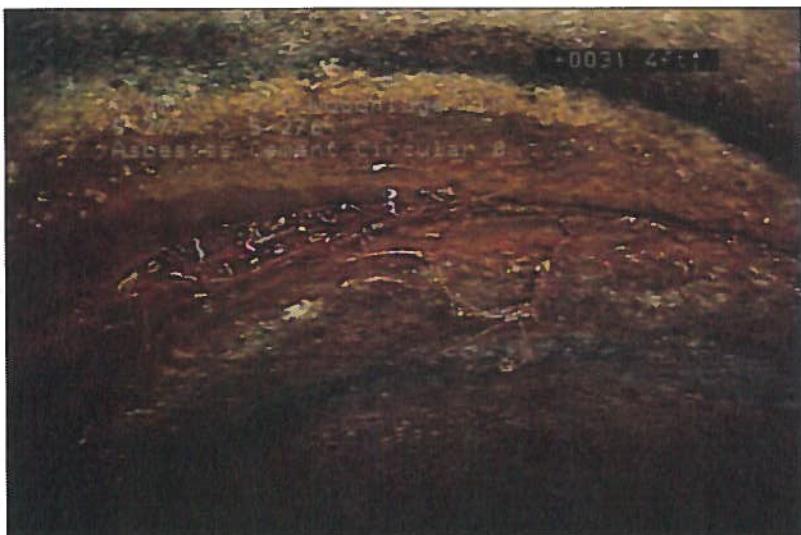
Photo: 84_85_542_A.JPG, VCR No.: disc #10
31.1FT, Infiltration Runner, from 12 to 12 o'clock, within 8 inches of joint: YES

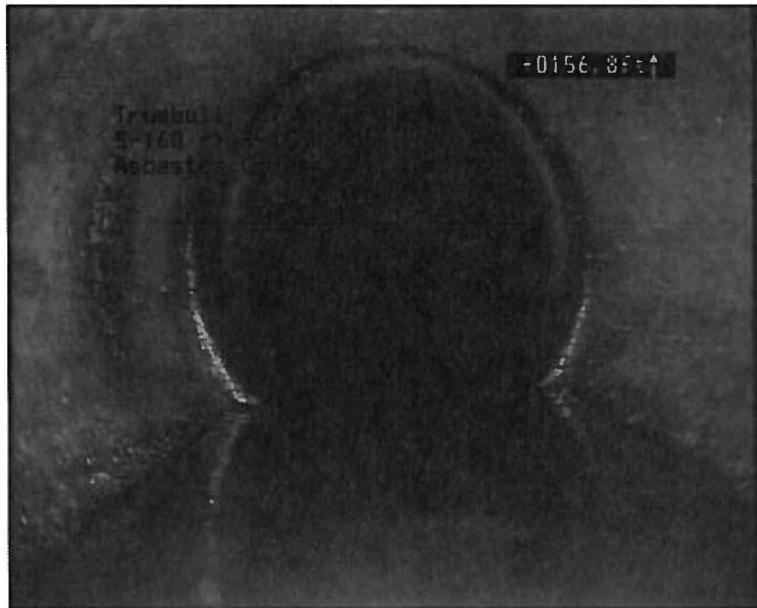
Photo: 41_42_332_A.JPG, VCR No.: Tape 1
156.8FT, Infiltration Runner, from 09 to 12 o'clock, within 8 inches of
joint: YES

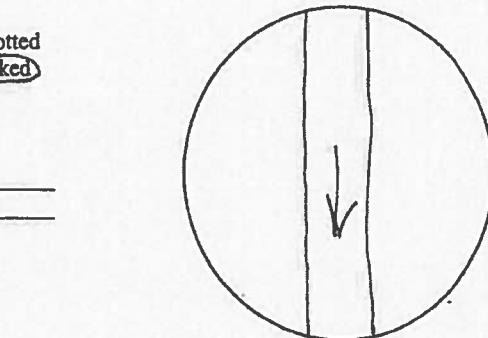
COMMENTS (REQUIRED): EVIDENCE OF LEAKING WALLS SECTION _____

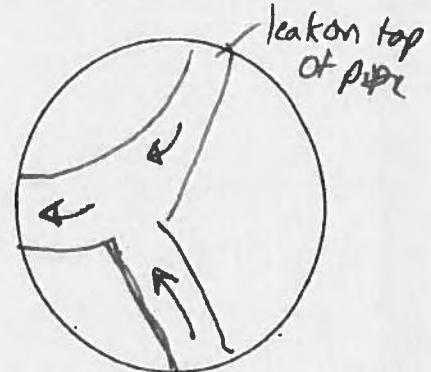
COMMENTS (REQUIRED): infiltration coming through lift hole
at top of manning pipe SECTION

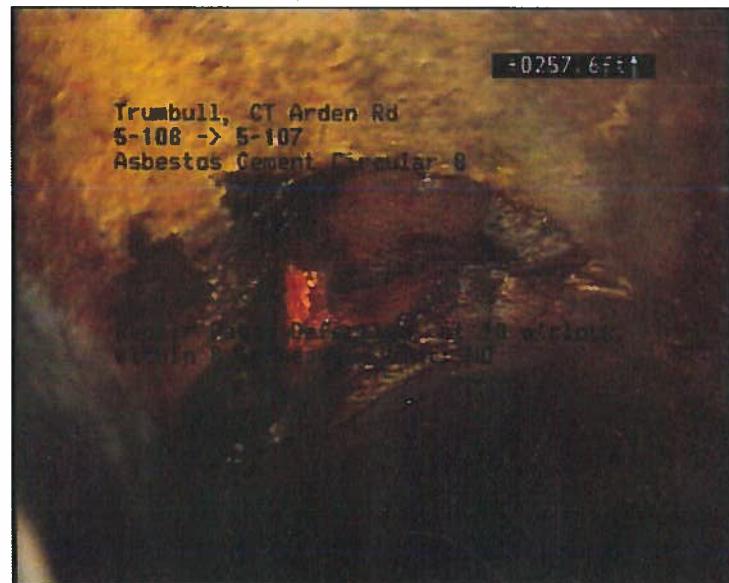
Photo: 31_32_263_A.JPG, VCR No.: Tape 1
257.6FT, Repair Patch Defective, at 10 o'clock, within 8 inches of joint:
NO

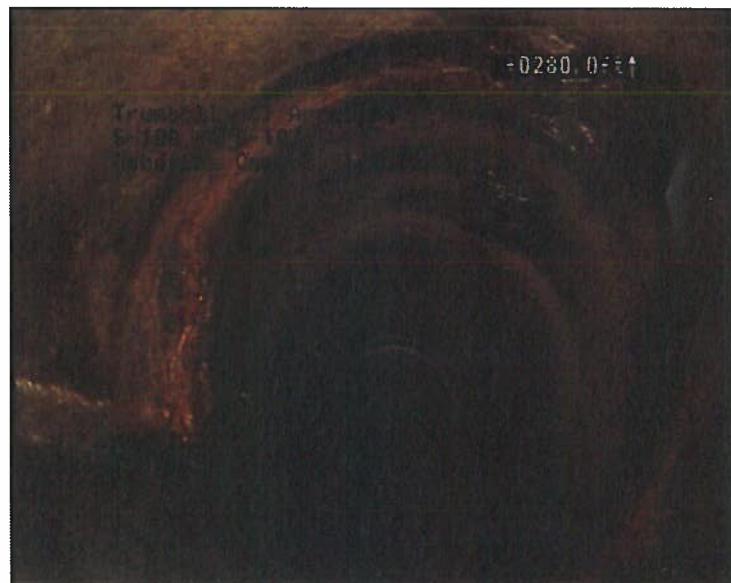
Photo: 31_32_265_A.JPG, VCR No.: Tape 1
280FT, Infiltration Runner, at 10 o'clock, within 8 inches of joint: YES

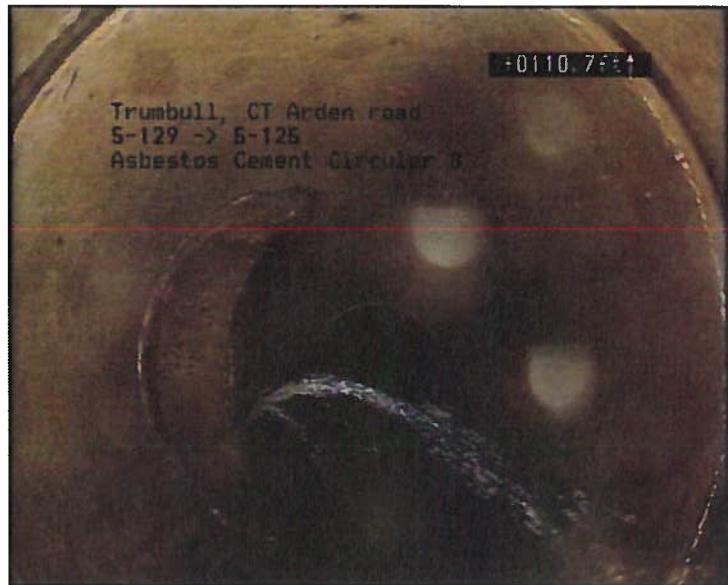
Photo: 19_20_148_A.JPG, VCR No.: Tape 1
110.7FT, Infiltration Gusher, at 10 o'clock, within 8 inches of joint: NO

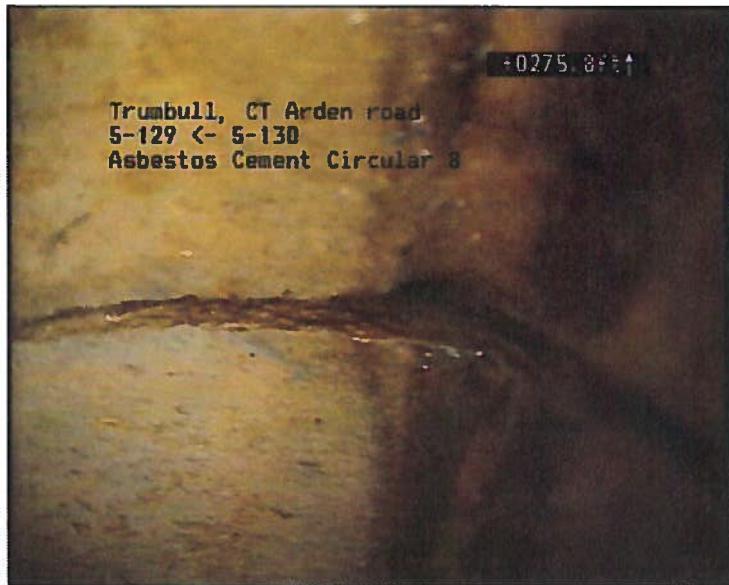
Photo: 18_19_139_A.JPG, VCR No.: Tape 1
275.6FT, Crack Circumferential, from 12 to 11 o'clock, within 8 inches of joint: NO

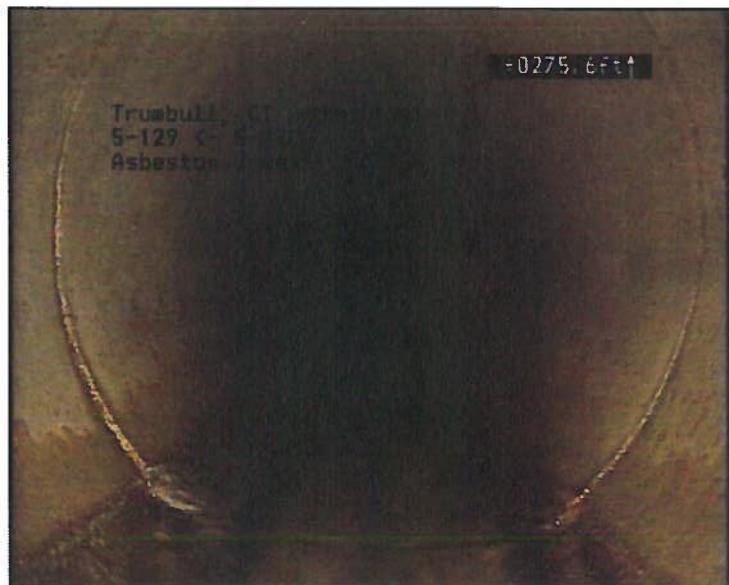
Photo: 18_19_140_A.JPG, VCR No.: Tape 1
275.6FT, Infiltration Gusher, from 04 to 08 o'clock, within 8 inches of joint: NO

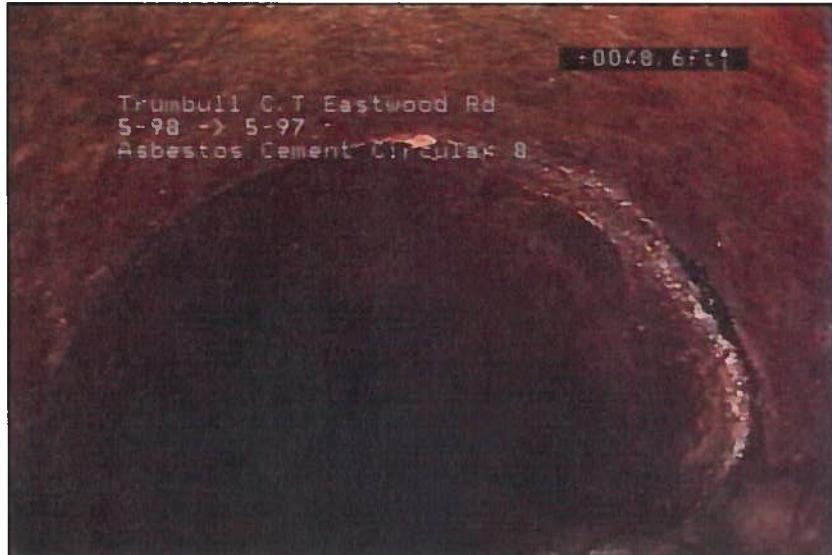
Photo: 47_48_280_A.JPG, VCR No.: disc #6
48.6FT, Infiltration Gusher, from 04 to 08 o'clock, within 8 inches of
joint: YES

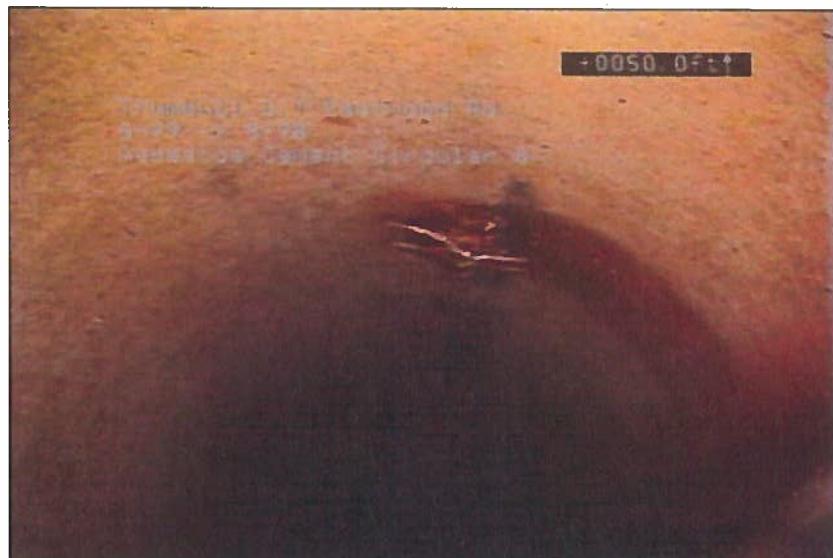
Photo: 46_47_271_A.JPG, VCR No.: disc #6
50FT, Infiltration Weeper, at 01 o'clock, within 8 inches of joint: NO

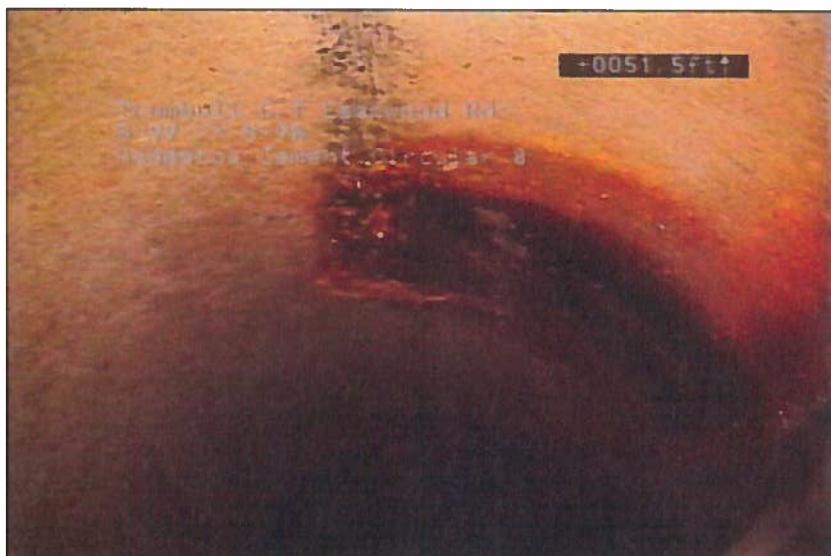
Photo: 46_47_273_A.JPG, VCR No.: disc #6
51.5FT, Infiltration Weeper, at 02 o'clock, within 8 inches of joint: NO

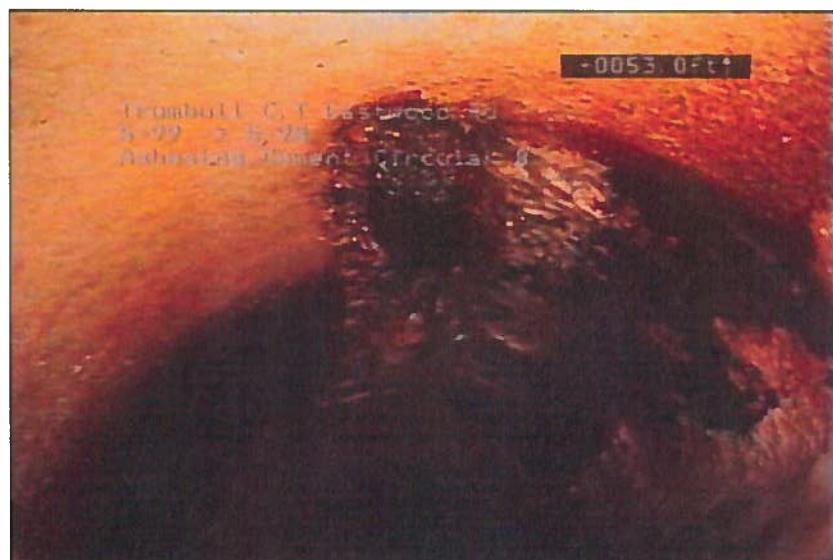
Photo: 46_47_275_A.JPG, VCR No.: disc #6
53FT, Infiltration Runner, at 02 o'clock, within 8 inches of joint: YES

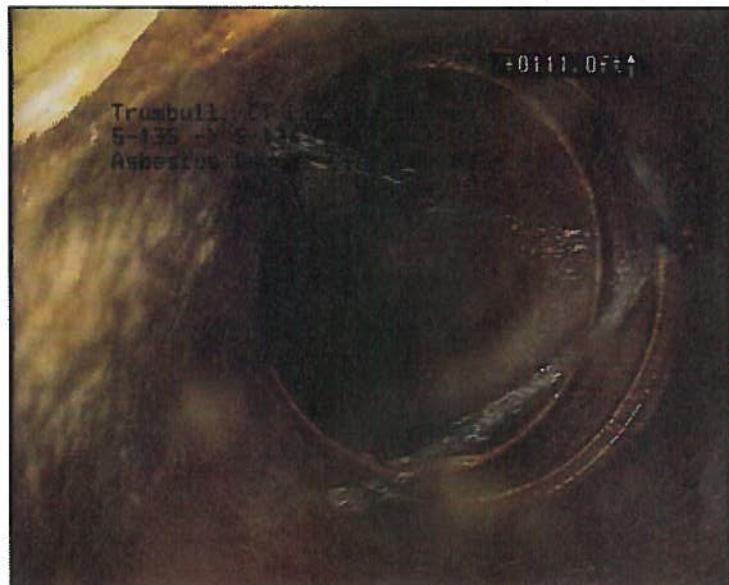
Photo: 17_18_127_A.JPG, VCR No.: Tape 1
 111FT, Tap Factory Made Defective, at 10 o'clock, 6", within 8 inches
 of
 joint: NO

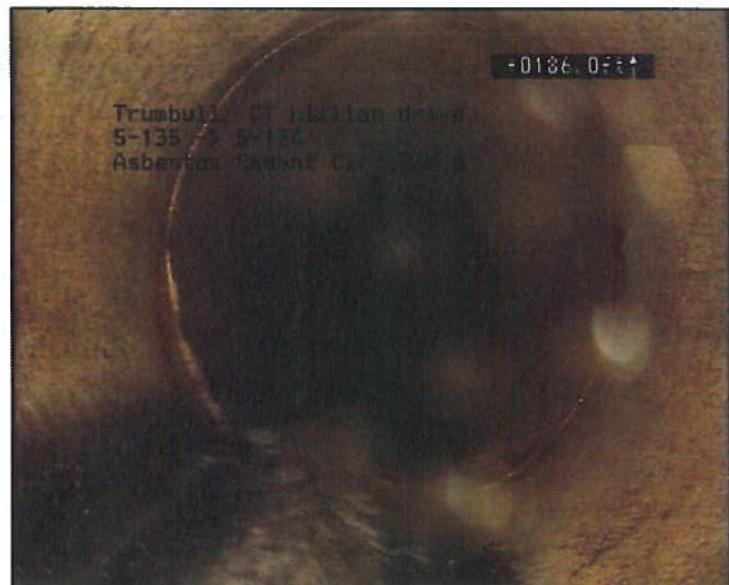
Photo: 17_18_129_A.JPG, VCR No.: Tape 1
 185.9FT, Fracture Circumferential, from 12 to 11 o'clock, within 8
 inches of joint: NO

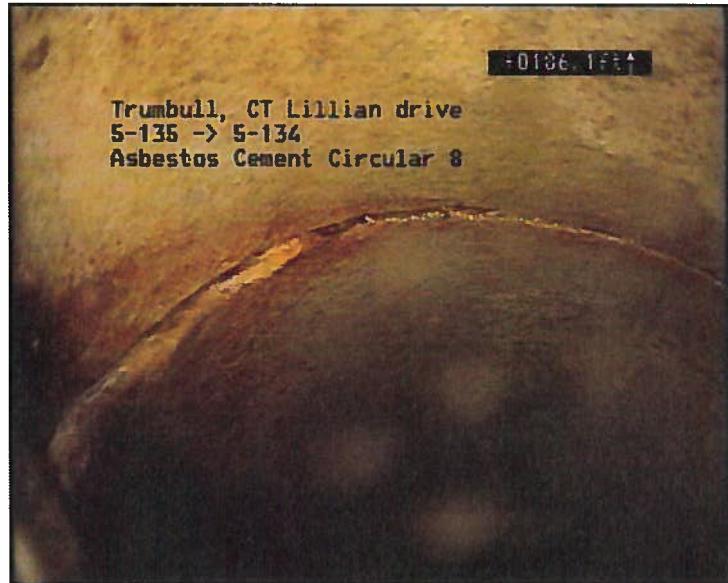
Photo: 17_18_130_A.JPG, VCR No.: Tape 1
186FT, Infiltration Gusher, from 06 to 09 o'clock, within 8 inches of
joint:
NO

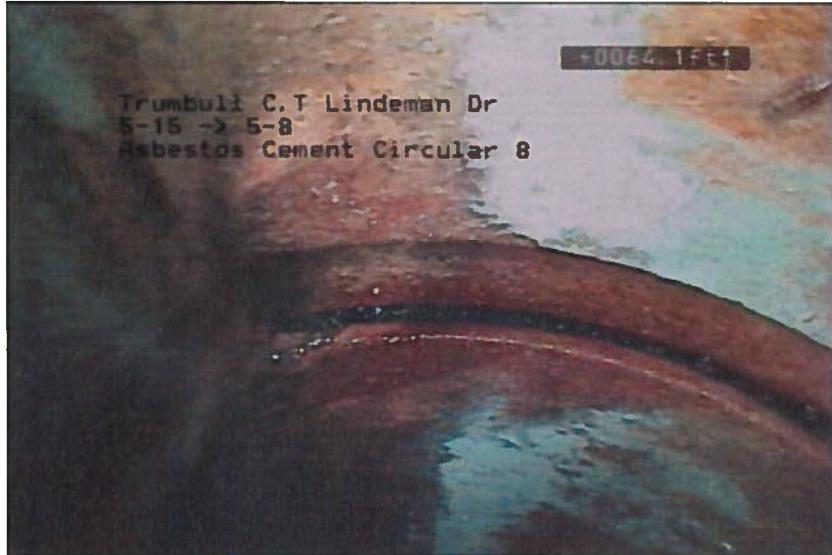
Photo: 199_200_1147_A.JPG, VCR No.: disc #20
64.1FT, Infiltration Runner, at 07 o'clock, within 8 inches of joint: YES

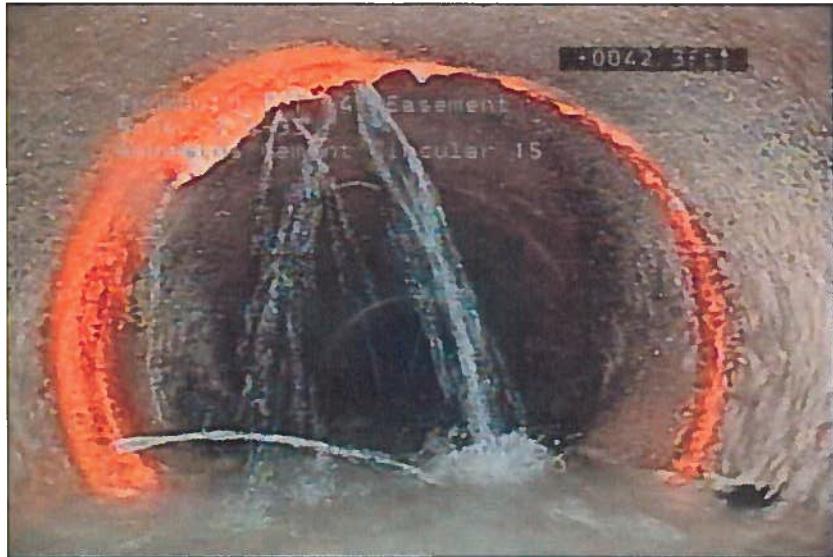
Photo: 154_155_960_A.JPG, VCR No.: disc #17
42.3FT, Infiltration Gusher, from 12 to 12 o'clock, within 8 inches of joint: YES

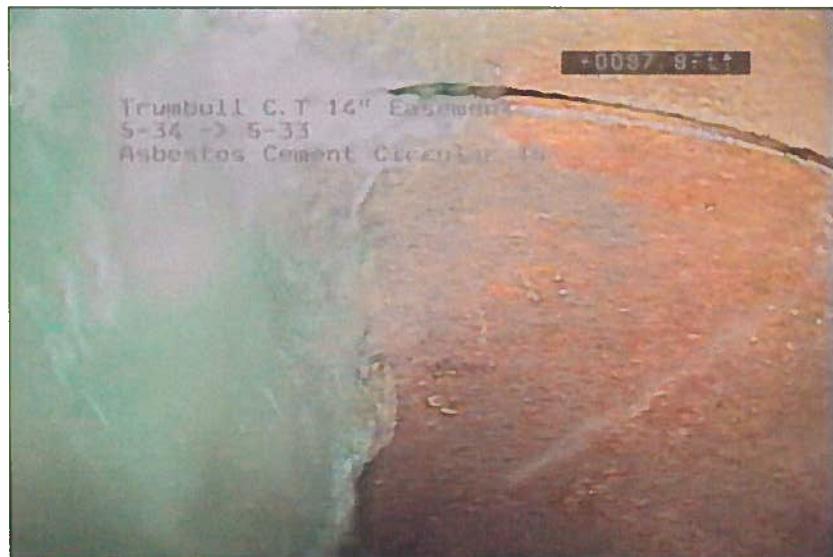
Photo: 154_155_961_A.JPG, VCR No.: disc #17
87.8FT, Infiltration Gusher, at 08 o'clock, within 8 inches of joint: YES

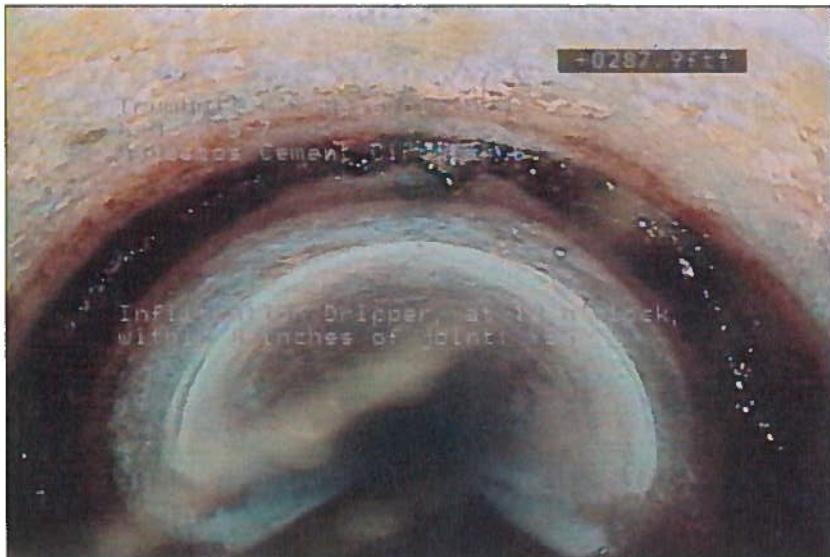
Photo: 182_183_1073_A.JPG, VCR No.: disc #19
287.9FT, Infiltration Dripper, at 12 o'clock, within 8 inches of joint: YES

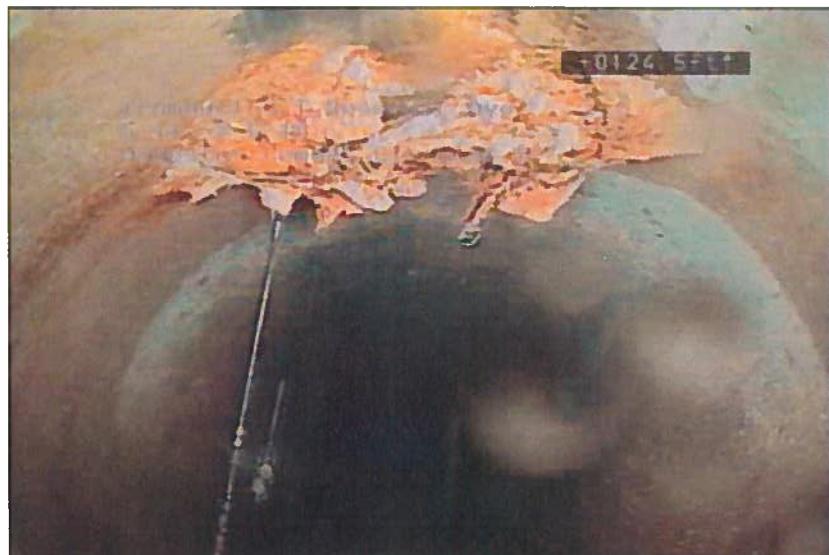
Photo: 179_180_1055_A.JPG, VCR No.: disc #18
124.5FT, Infiltration Runner, at 11 o'clock, within 8 inches of joint: YES

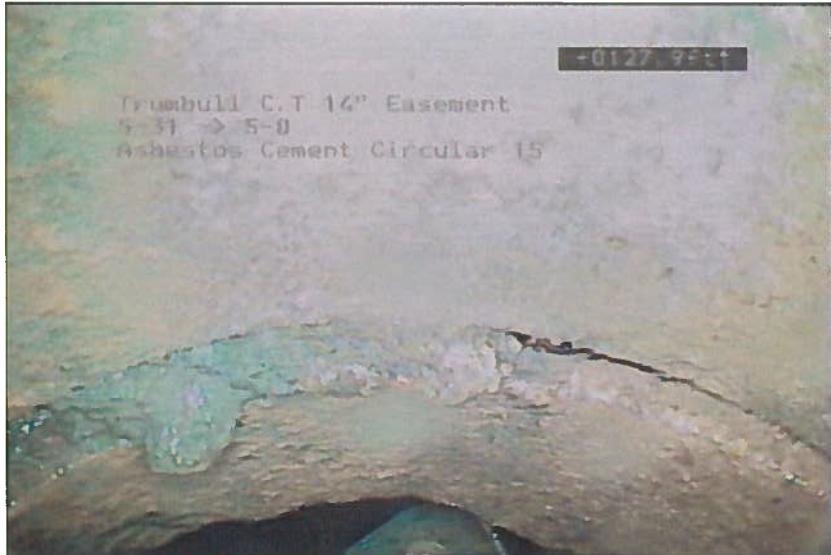
Photo: 157_158_969_A.JPG, VCR No.: disc #17
127.9FT, Infiltration Runner, from 01 to 04 o'clock, within 8 inches of
joint: YES

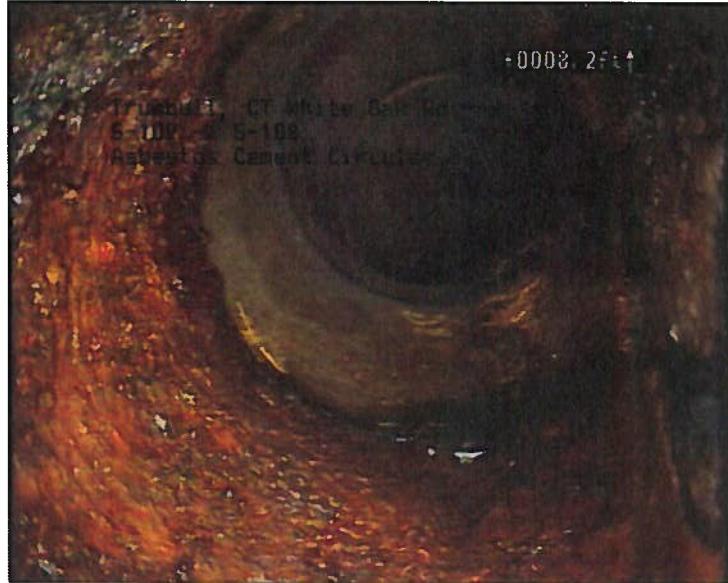
Photo: 30_31_249_A.JPG, VCR No.: Tape 1
8.1FT, Tap Saddle Defective, at 02 o'clock, 6", within 8 inches of joint:
NO

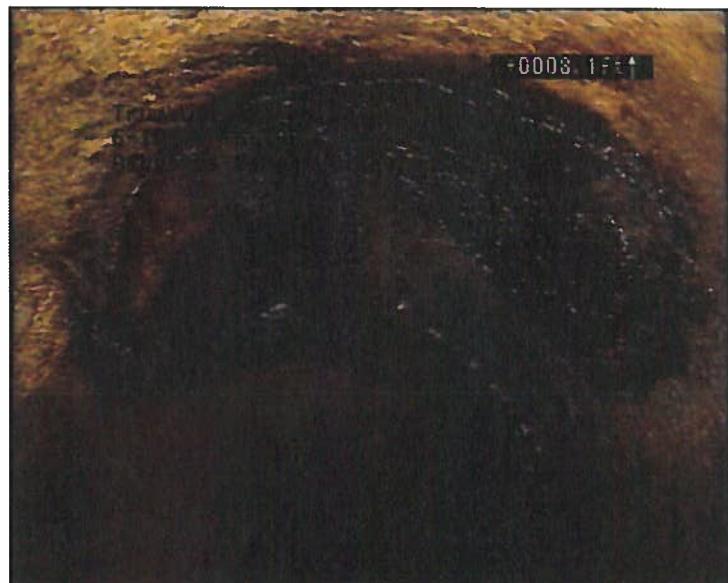
Photo: 30_31_250_A.JPG, VCR No.: Tape 1
8.1FT, Deposits Attached Encrustation, 5 % of Cross Sectional Area,
From 12 to 04 o'clock, Within 8 inches of joint: NO

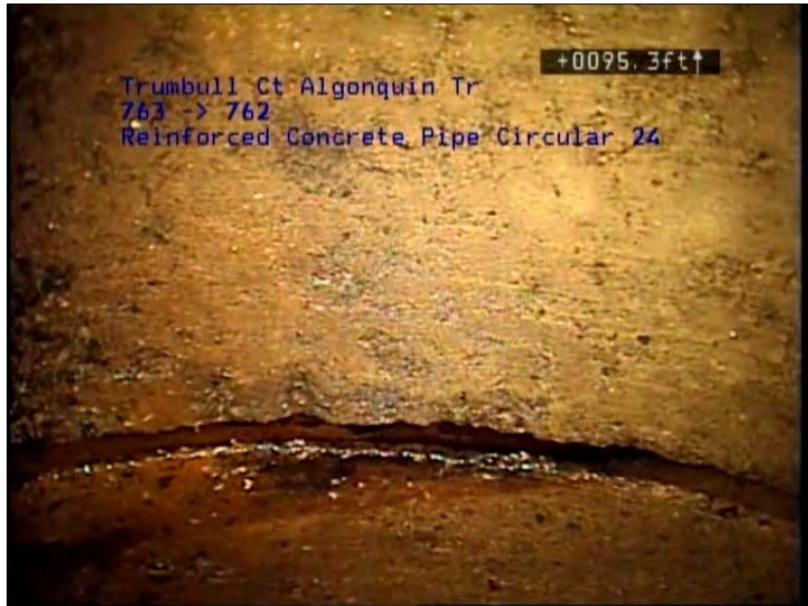
Photo: 516_516_2604_A.jpg, VCR No.: 47
95.4FT, Infiltration Runner, from 06 to 09 o'clock, within 8 inches of
joint: YES

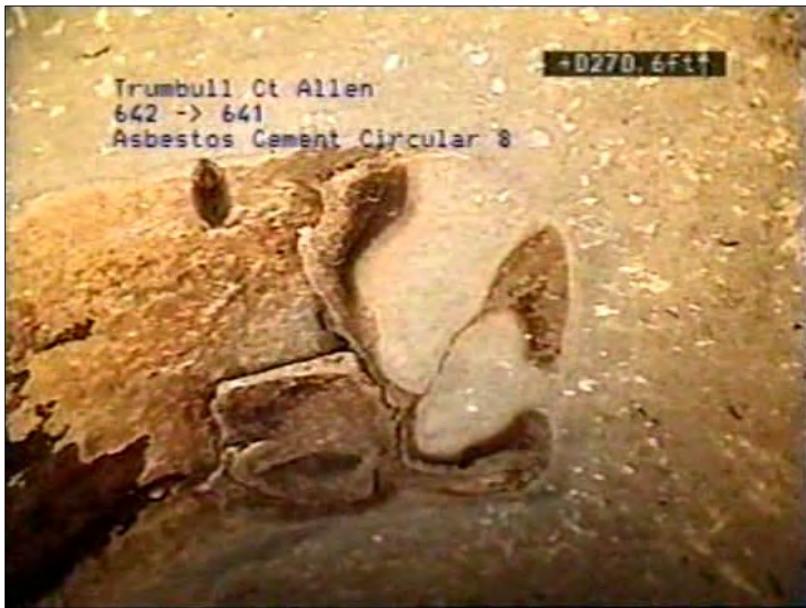
Photo: 56_56_328_A.jpg, VCR No.: Disc 7
270.6FT, Broken, at 11 o'clock, within 8 inches of joint: NO

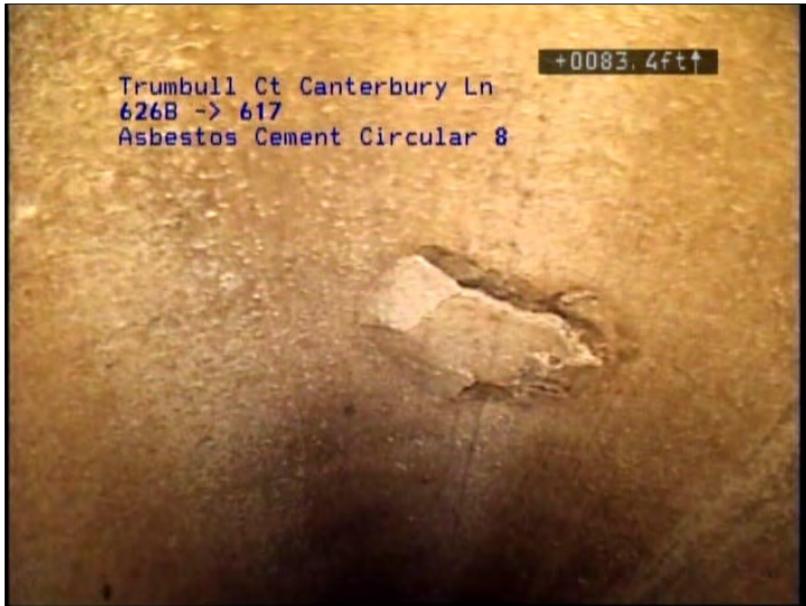
Photo: 155_155_856_A.jpg, VCR No.: Disc 12
83.4FT, Broken, from 12 to 01 o'clock, within 8 inches of joint: NO

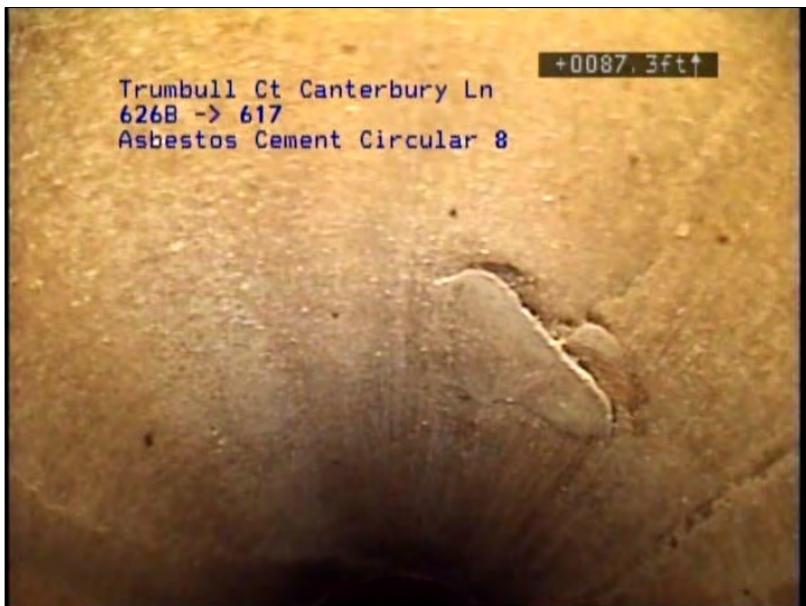
Photo: 155_155_857_A.jpg, VCR No.: Disc 12
87.3FT, Broken, from 12 to 01 o'clock, within 8 inches of joint: NO

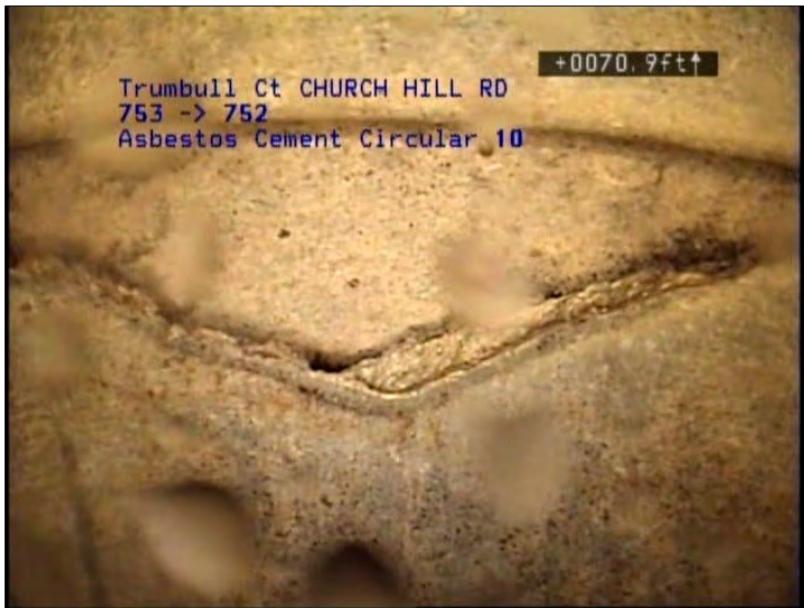
Photo: 378_378_1886_A.jpg, VCR No.: Disc 33
70.9FT, Broken, at 12 o'clock, within 8 inches of joint: YES

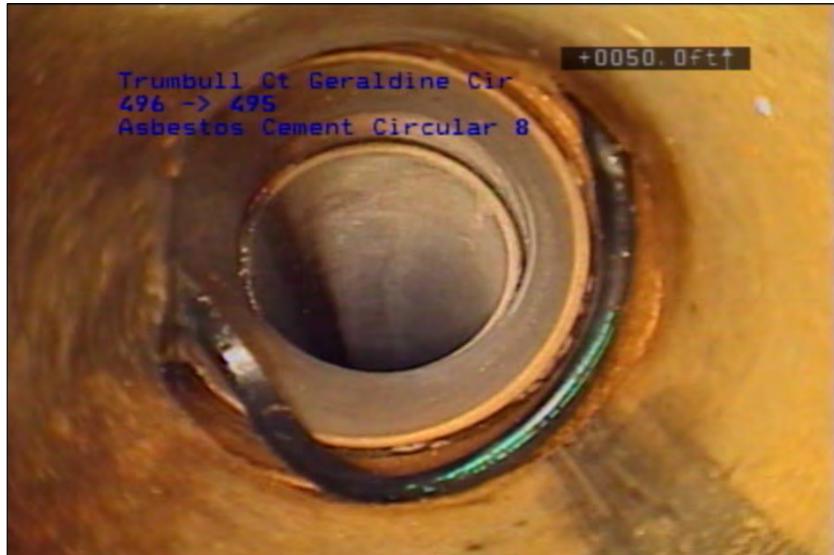
Photo: 215_215_2845_A.jpg, VCR No.: Disc 17
50FT, Infiltration Gusher, at 12 o'clock, within 8 inches of joint: NO

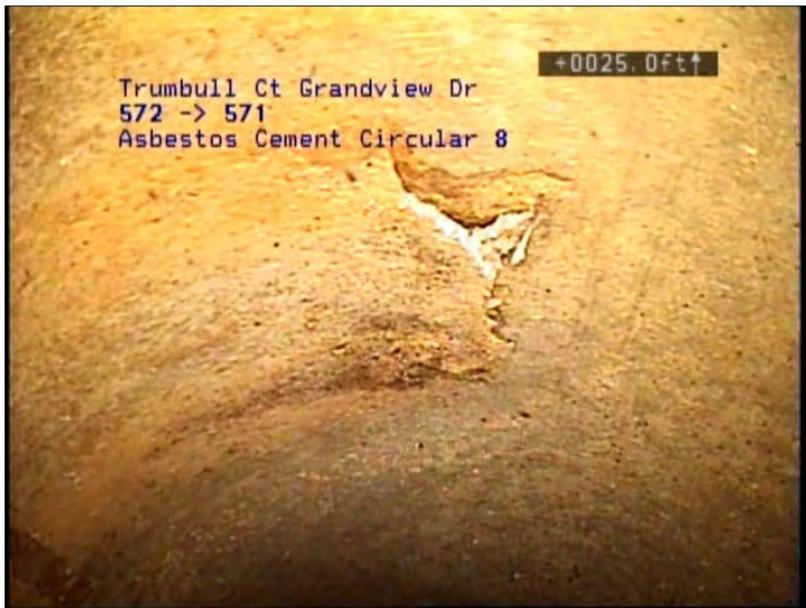
Photo: 252_252_1324_A.jpg, VCR No.: Disc 22
25FT, Broken, from 09 to 10 o'clock, within 8 inches of joint: NO

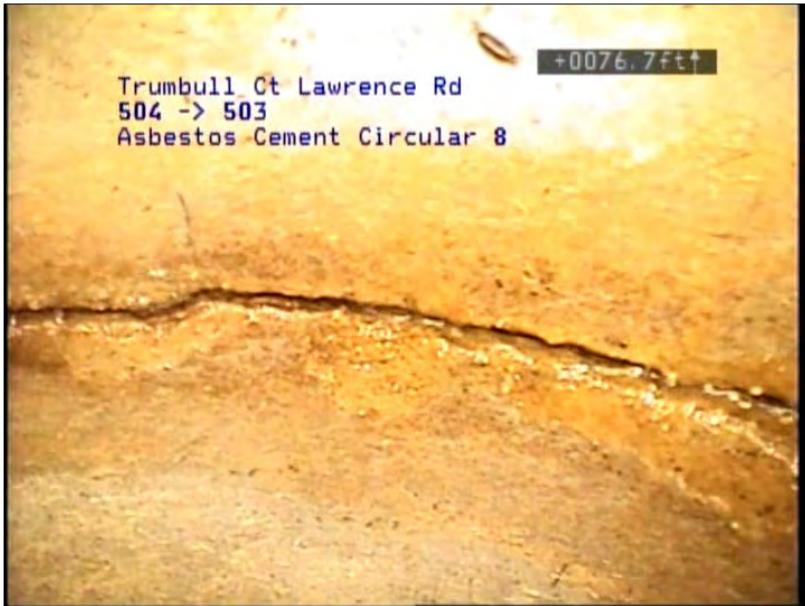
Photo: 241_241_1251_A.jpg, VCR No.: Disc 20
76.7FT, Infiltration Runner, from 12 to 11 o'clock, within 8 inches of joint: NO
