APPENDIX A
Area A Manhole Inspection Reports

Project Name: Trumbull 9/9 MANHOLE INSPECTION REPORTSubsystem Name/No. 5Manhole ID No. 5337Rating System (NASSCO)

Trumbull, CTPROJECT NO.: 12051 DDATE: 8/30/2011WEATHER: SunnyTIME: 3:16 pmINSPECTOR: mm, nke

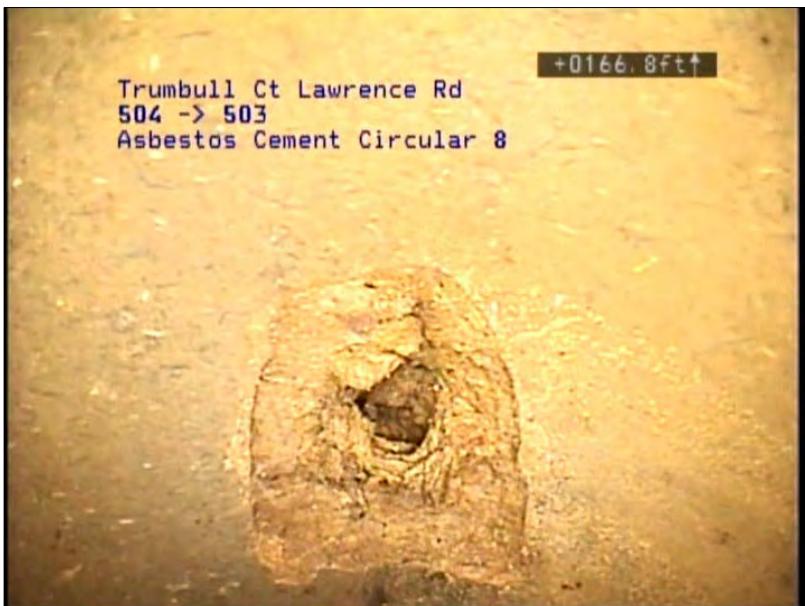
Photo: 241_241_1253_A.jpg, VCR No.: Disc 20
166.8FT, Hole Void Visible, at 01 o'clock, within 8 inches of joint: NO

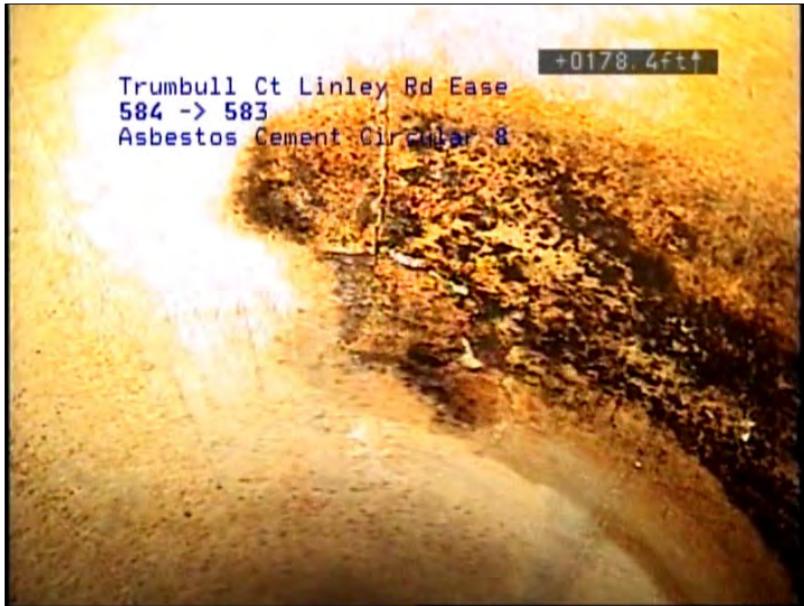
Photo: 187_187_979_A.jpg, VCR No.: Disc 15
178.4FT, Broken, from 01 to 02 o'clock, within 8 inches of joint: NO

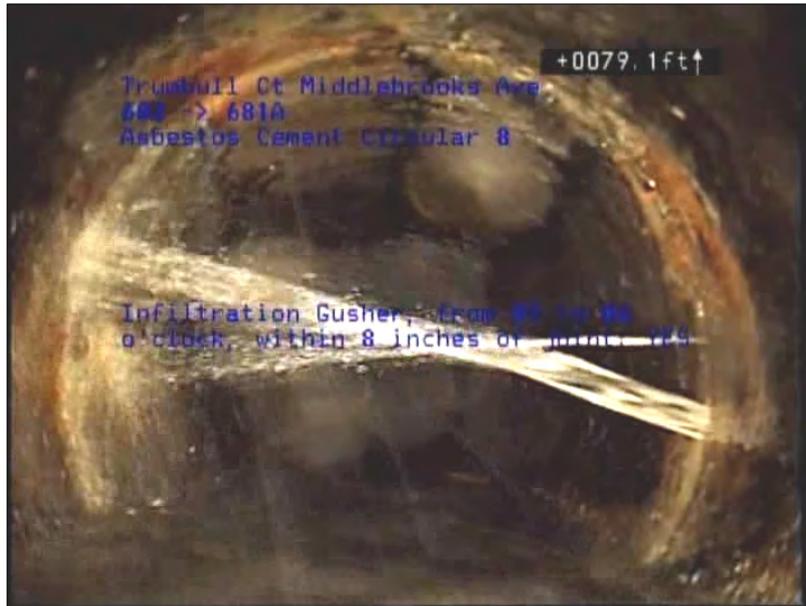
Photo: 232_232_1195_A.jpg, VCR No.: Disc 19
79.1FT, Infiltration Gusher, from 03 to 04 o'clock, within 8 inches of joint: YES

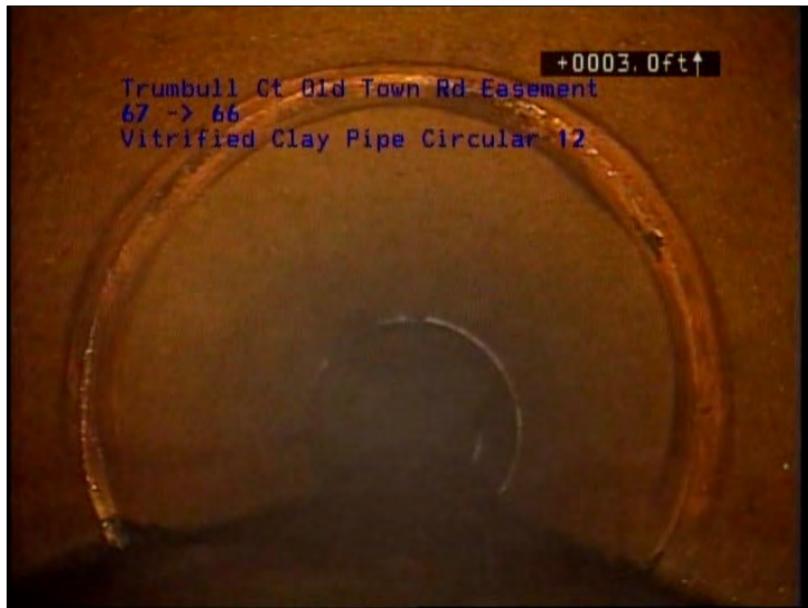
Photo: 535_535_2700_A.jpg, VCR No.: 49
3FT, Infiltration Runner, from 12 to 12 o'clock, within 8 inches of joint:
YES

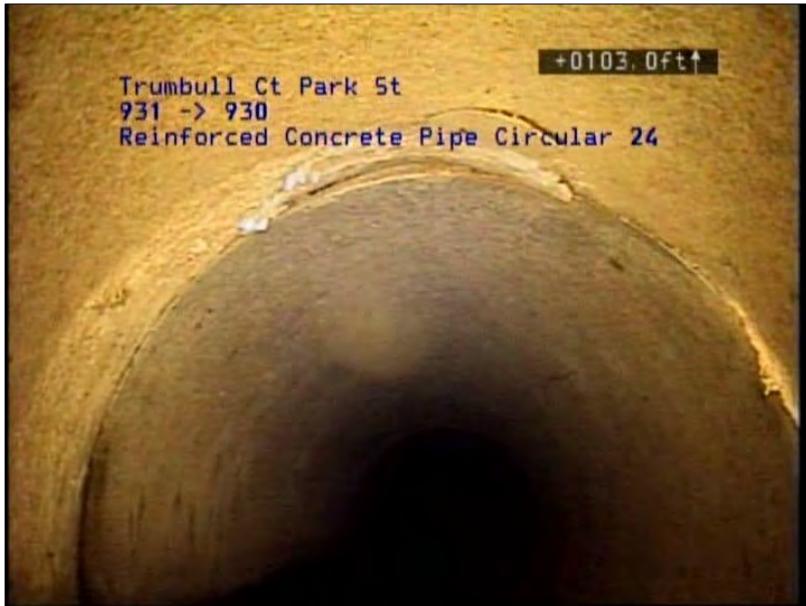
Photo: 499_499_2517_A.jpg, VCR No.: 45
103FT, Broken, from 10 to 12 o'clock, within 8 inches of joint: YES

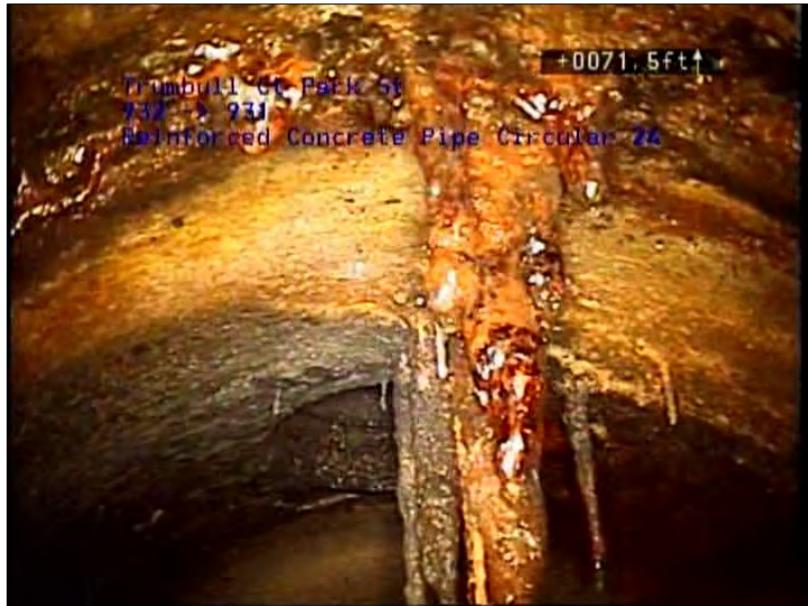
Photo: 498_498_2509_A.jpg, VCR No.: 44
71.5FT, Infiltration Runner, from 06 to 10 o'clock, within 8 inches of
joint: YES

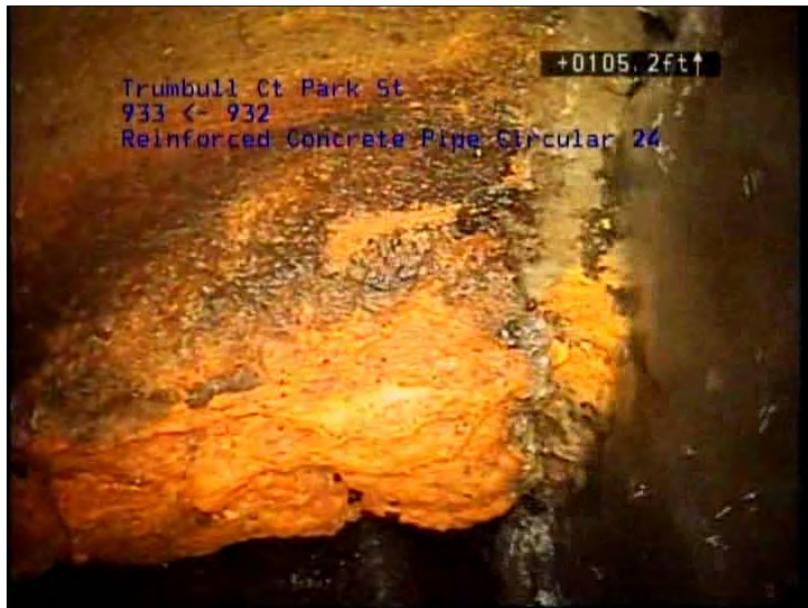
Photo: 497_497_2501_A.jpg, VCR No.: 44
106FT, Infiltration Runner, from 03 to 05 o'clock, within 8 inches of
joint:
NO

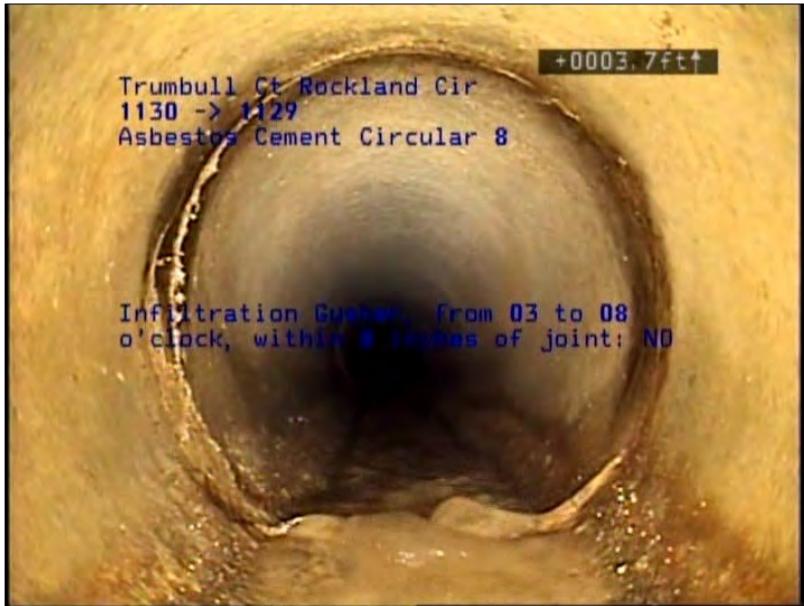
Photo: 302_302_1542_A.jpg, VCR No.: Disc 26
3.7FT, Infiltration Gusher, from 03 to 08 o'clock, within 8 inches of joint:
NO

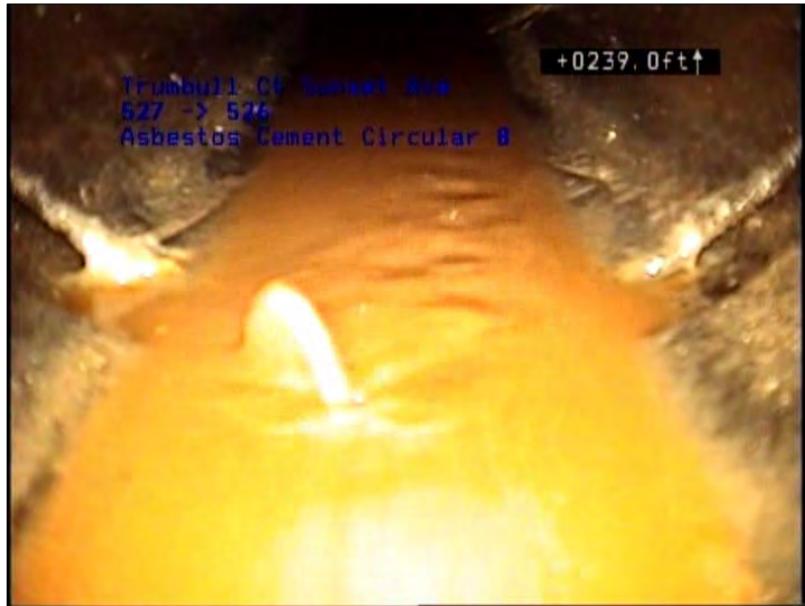
Photo: 281_281_1459_A.jpg, VCR No.: Disc 24
239FT, Infiltration Gusher, at 06 o'clock, within 8 inches of joint: YES

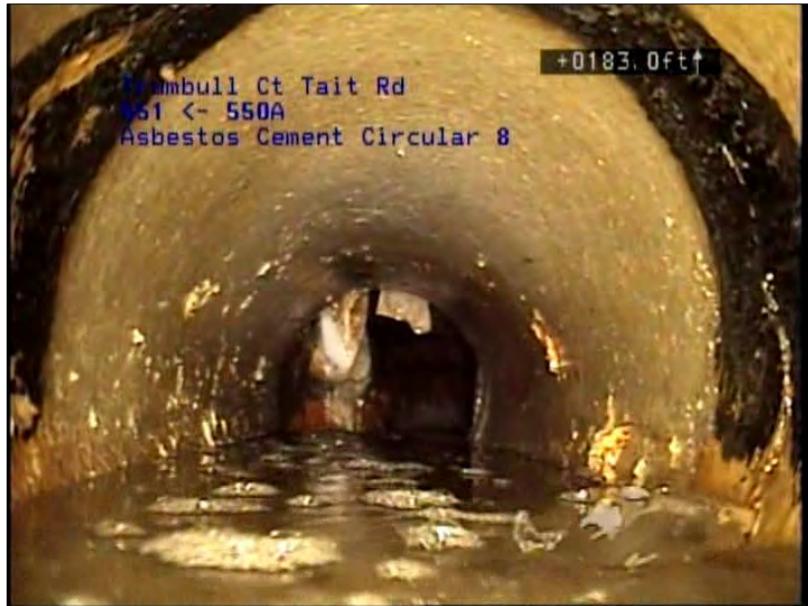
Photo: 334_334_1689_A.jpg, VCR No.: Disc 28
183.4FT, Infiltration Gusher, at 04 o'clock, within 8 inches of joint: YES

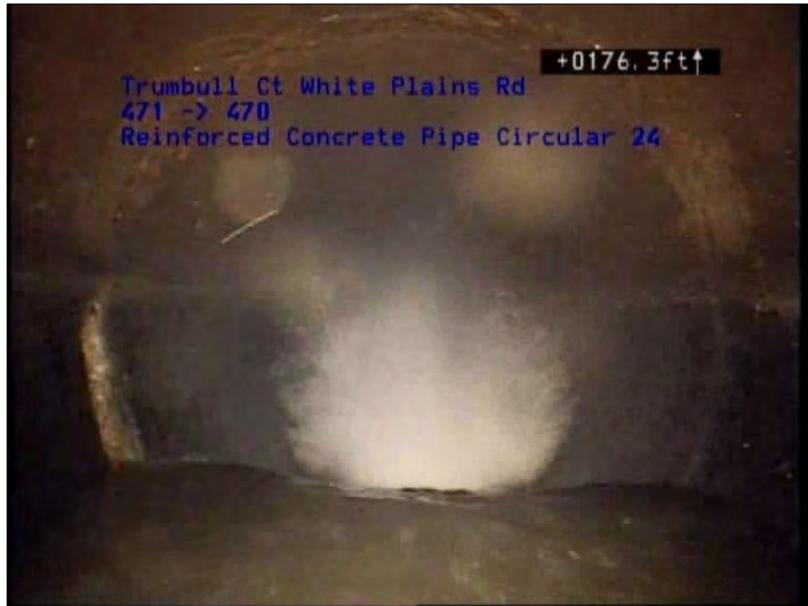
Photo: 524_524_2632_A.jpg, VCR No.: 47
176.3FT, Infiltration Gusher, at 10 o'clock, within 8 inches of joint: YES

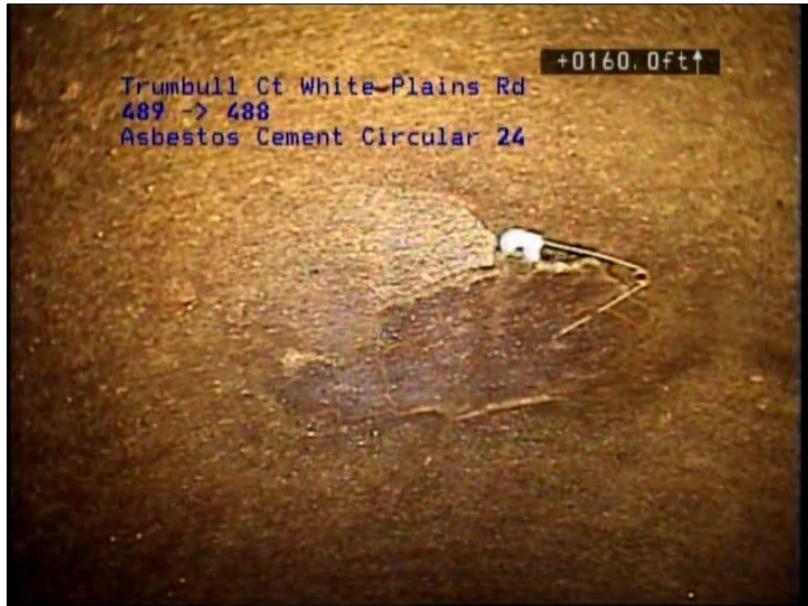
Photo: 452_452_2306_A.jpg, VCR No.: 39
160FT, Broken, from 12 to 01 o'clock, within 8 inches of joint: NO

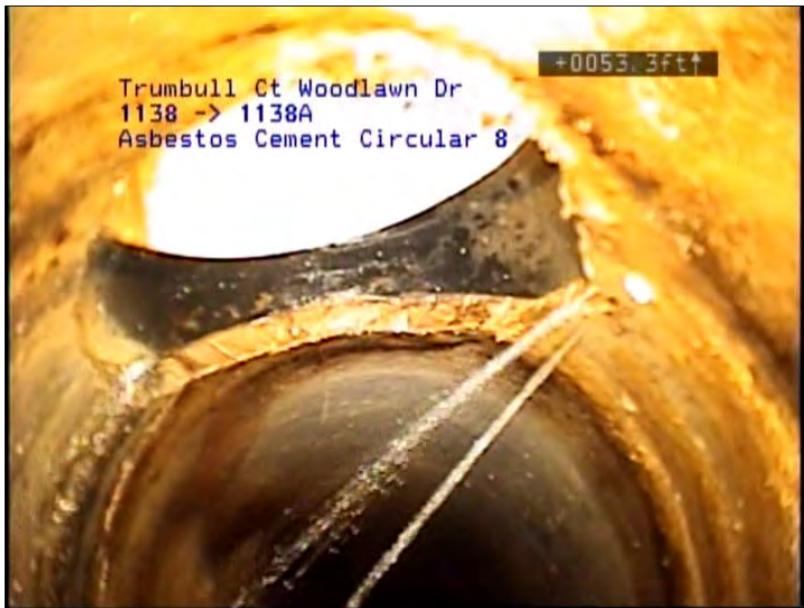
Photo: 291_291_1500_A.jpg, VCR No.: Disc 25
53.3FT, Infiltration Gusher, from 09 to 01 o'clock, within 8 inches of
joint: NO
