**MEETING MINUTES**  
**AQUATICS FACILITIES BUILDING COMMITTEE**

Date: January 20, 2022  
Project Name: Hillcrest School Natatorium and Swimming Pool  
TLBA Project No. 2021-012

Meeting: Presentation to Town-01  
Re: Review of Findings and Conceptual Design Options

## HILLCREST SCHOOL POOL

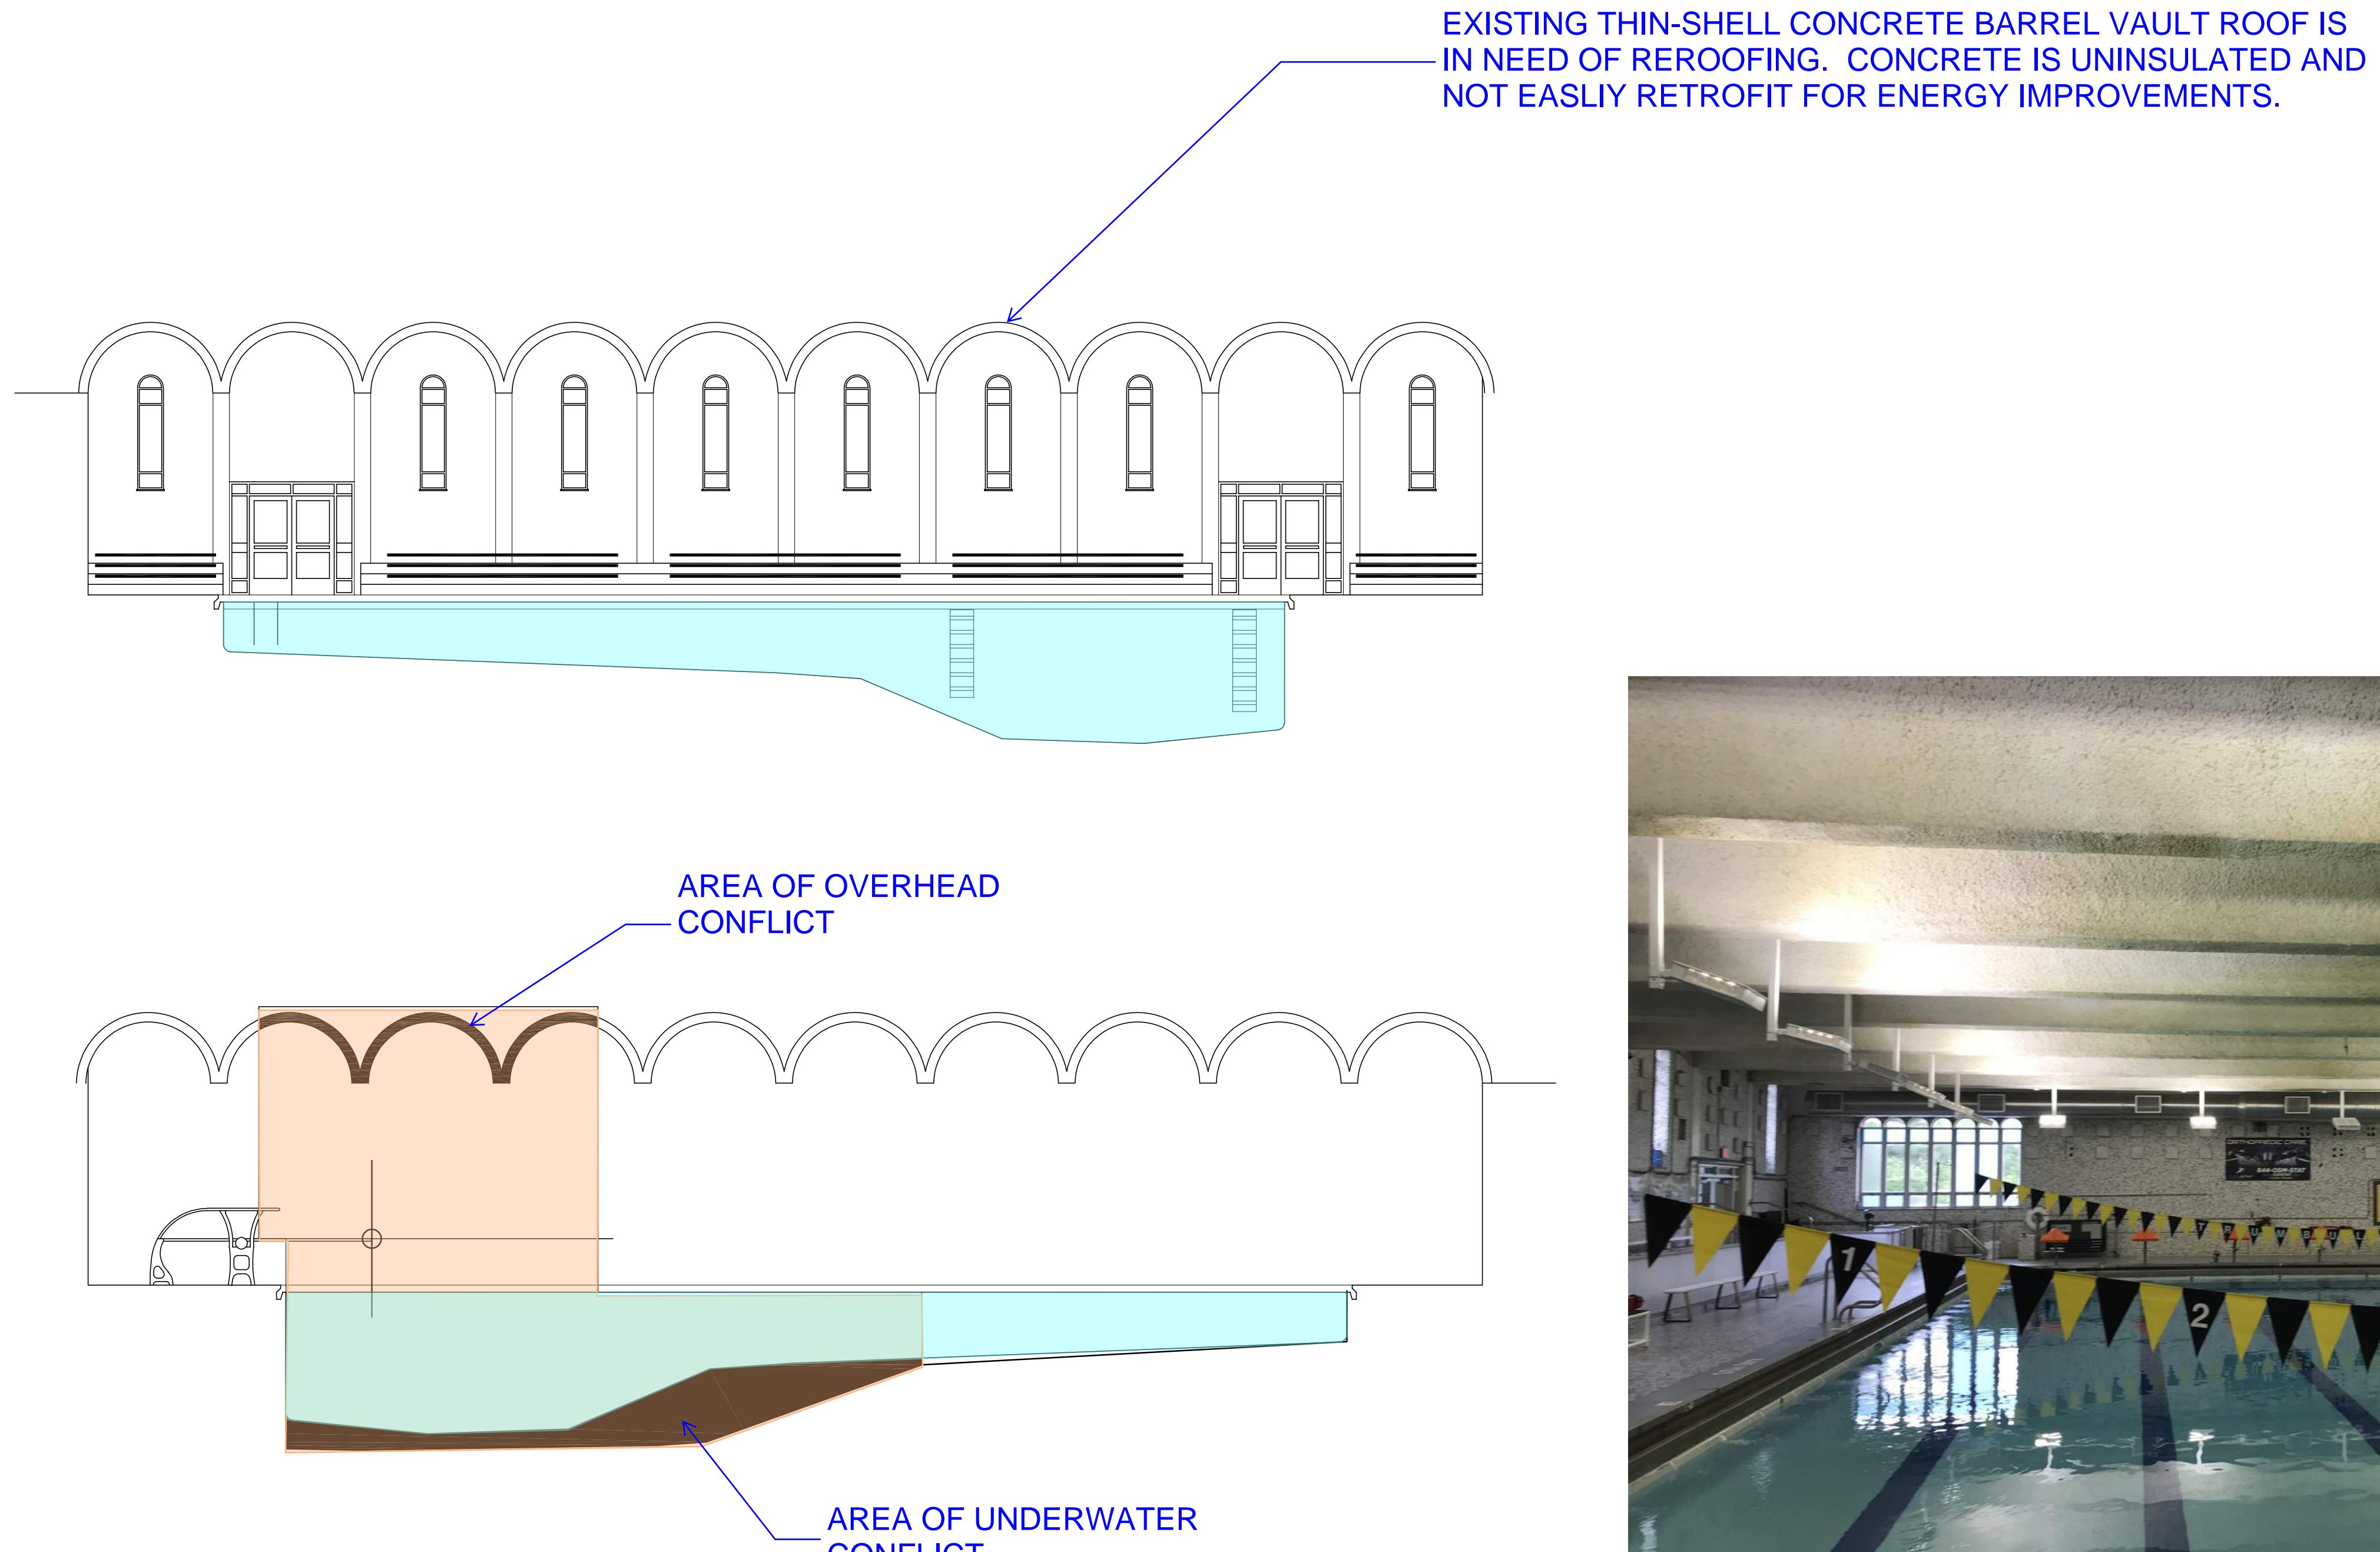
#### EXISTING BUILDING SECTIONS AND DIVING DEFICIENCIES

NO VIABLE OPTION EXISTS FOR PROVIDING 1-METER DIVING WITHIN THE FOOTPRINT OF THE EXISTING BUILDING, DUE TO OVERHEAD HEIGHT RESTRICTIONS.

NOTE: DIVING NOT VIABLE DUE TO POOL DEPTH AND CEILING HEIGHT

11. Diving Requirements: The diving board at the pool has been removed due to inadequate geometry of the pool and building. The pool is too shallow and the slope in front of the board is non-compliant as well. The overhead clearance to the underside of the roof structure is too low to provide adequate overhead clearance. There is no cost-effective approach to making a Code-compliant diving facility, within the footprint of the existing building. As such, any renovation scheme which includes a diving will need to expand beyond the footprint of the existing building, where more overhead clearance can be provided.

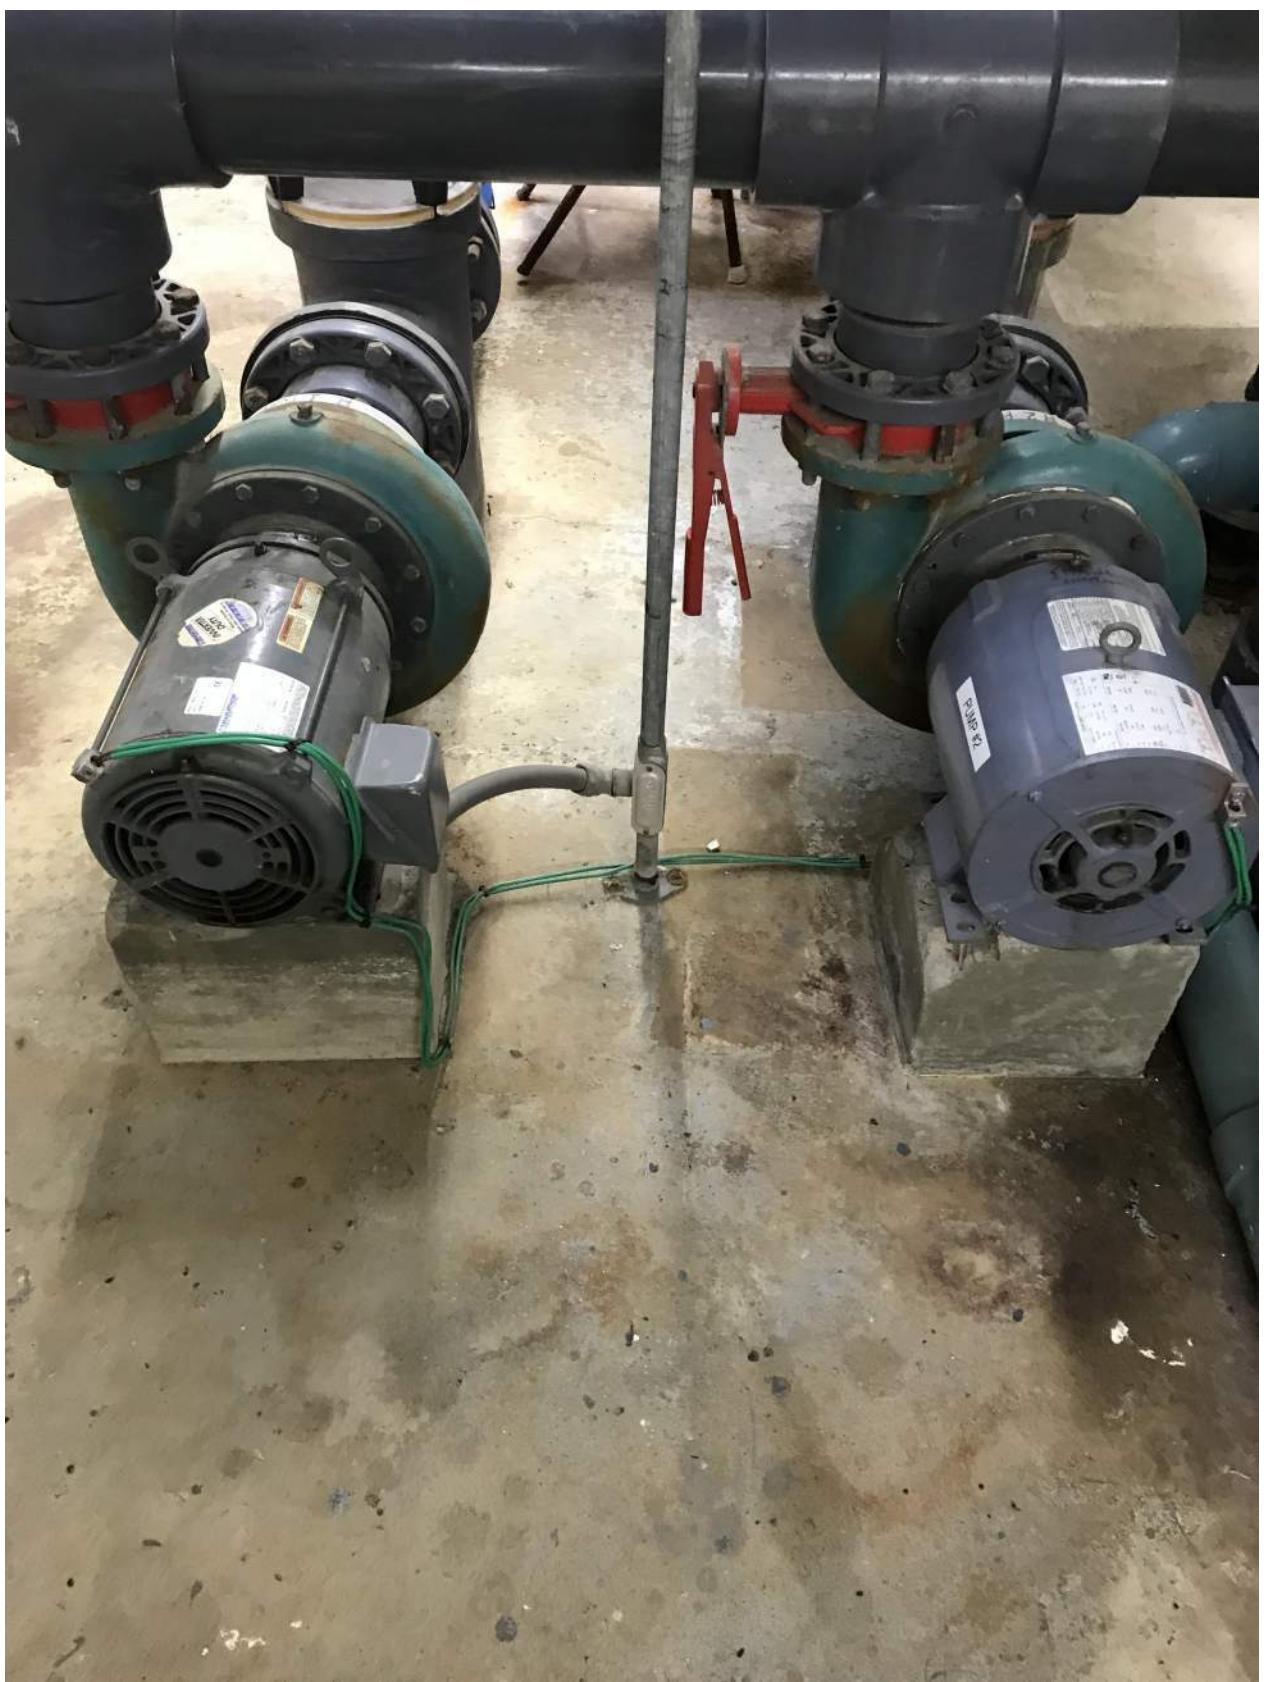
EXISTING FLOOR PLAN - LOWER LEVEL PLAN - POOL SYSTEM ISSUES

BALANCE TANK EMPLOYED AS THERE IS NO SURGE CAPACITY FOR THE GUTTER OVERFLOW. IT IS UNDERSIZED, AS ARE THE SURGE WEIRS IN THE GUTTER. AS A RESULT, SURFACE WATER WILL NOT SKIM EFFECTIVELY.

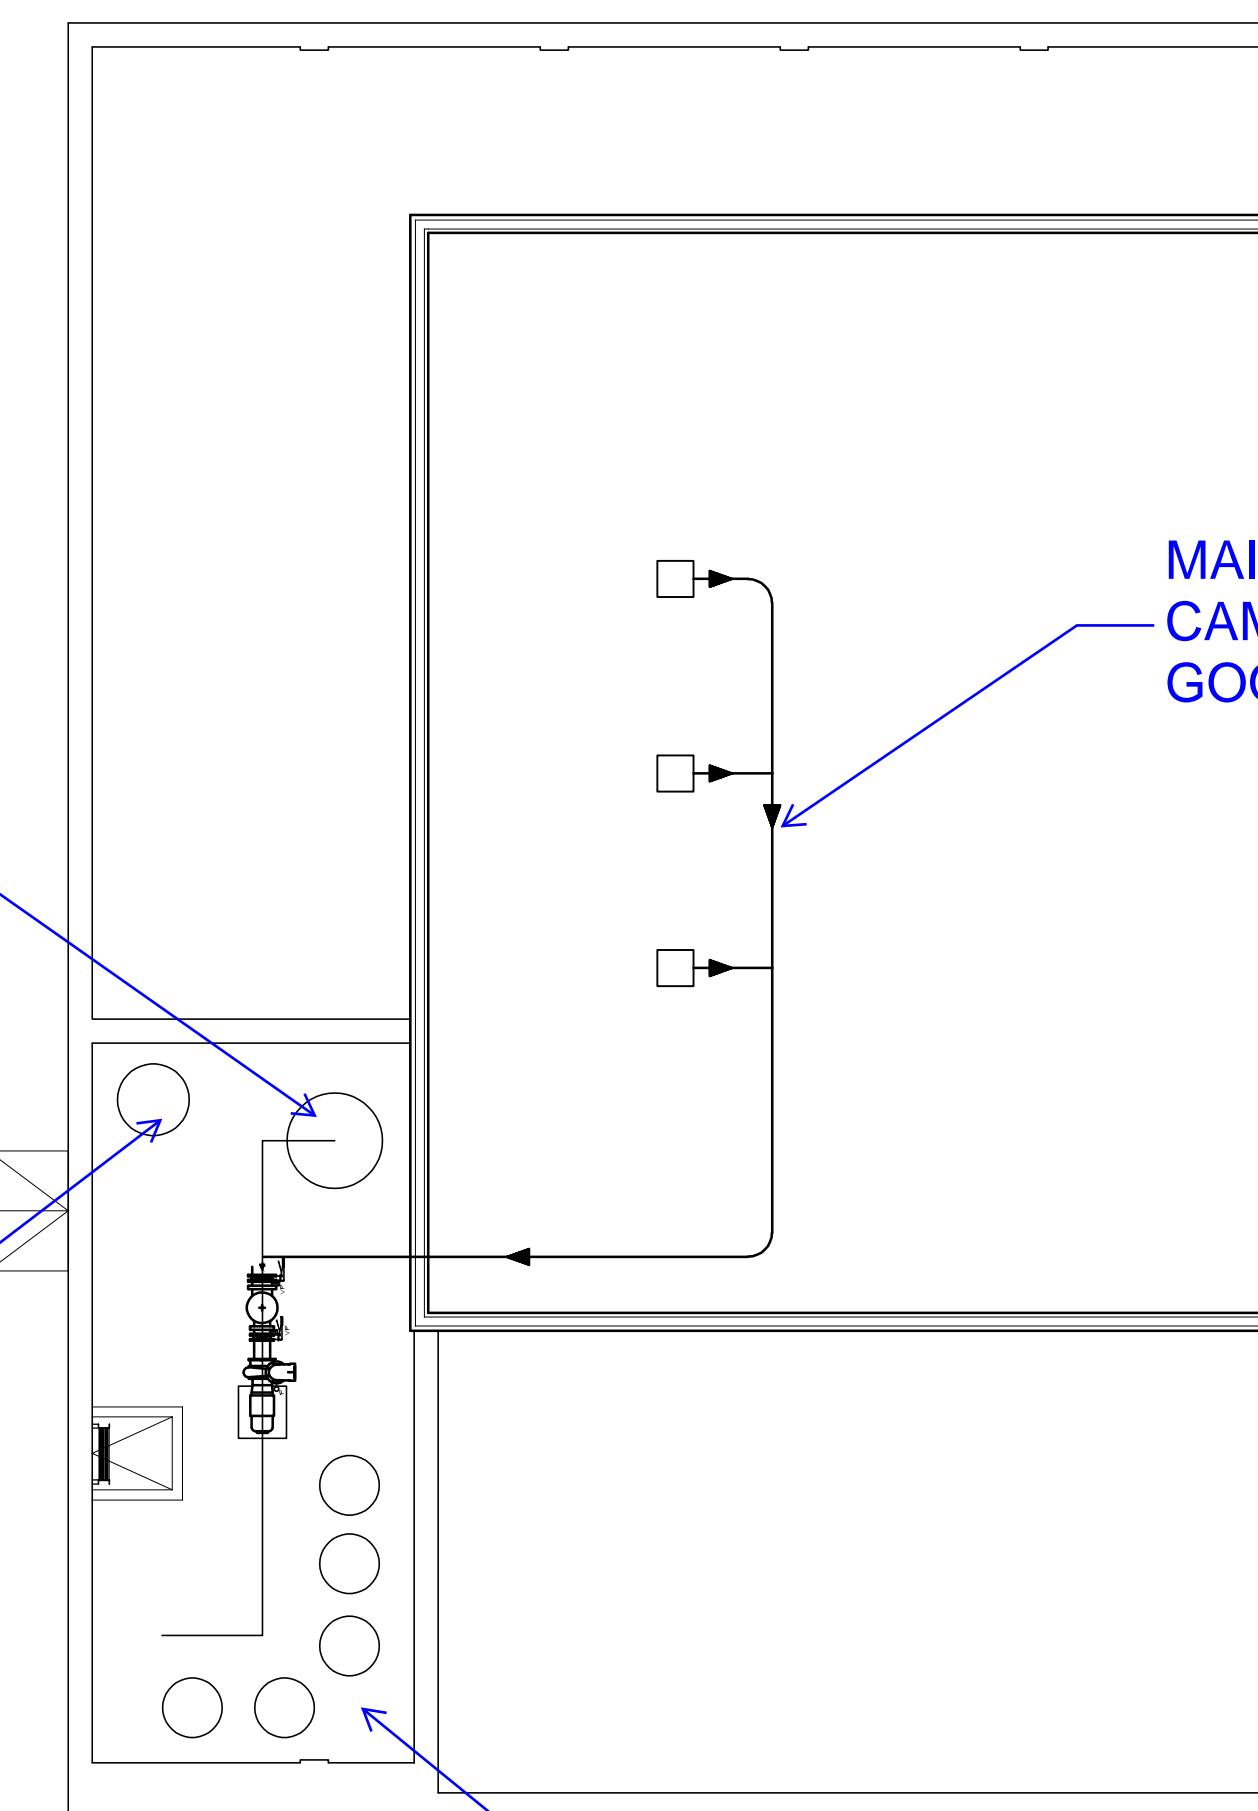
MAIN DRAIN SUMPS AND PIPING  
CAMERA INSPECTED AND ARE IN  
GOOD CONDITION.

FILTERS ARE A SET OF FIVE 36" SAND  
FILTERS AS OPPOSED TO A SINGLE,  
PROPERLY SIZED FILTER. THIS IS  
LESS THAN IDEAL BUT A RESULT OF  
LIMITED ACCESS.

5. Recirculation, Filtration and Chemical Control Systems: Existing systems are functional and well maintained, but are less than ideal for a pool of this size and type. The system includes dual recirculation pumps drawing from a balance tank. Pool filters are made up of five small diameter high-rate sand filters, manifolded together. Chemical control includes liquid acid and CO<sub>2</sub>, controlled by an automatic chemical controller. The use of five small sand filters is less

6. Camera Inspection of Piping: Camera inspection of main drains at the bottom of the pool indicated they are clean and in good condition. Deck drain piping is significantly calcified with a reduction in open area to less than half the original diameter. The converter box noted in Item 4 was inspected and it is in complete failure.
7. Structural Evaluation of Pool Shell: Concrete cores were extracted from the pool walls, pool floor and pool decks. Generally, concrete strength was acceptable for continued use. There were localized concerns at the shallow end wall and the deep end floor which may warrant further evaluation if the pool is renovated.

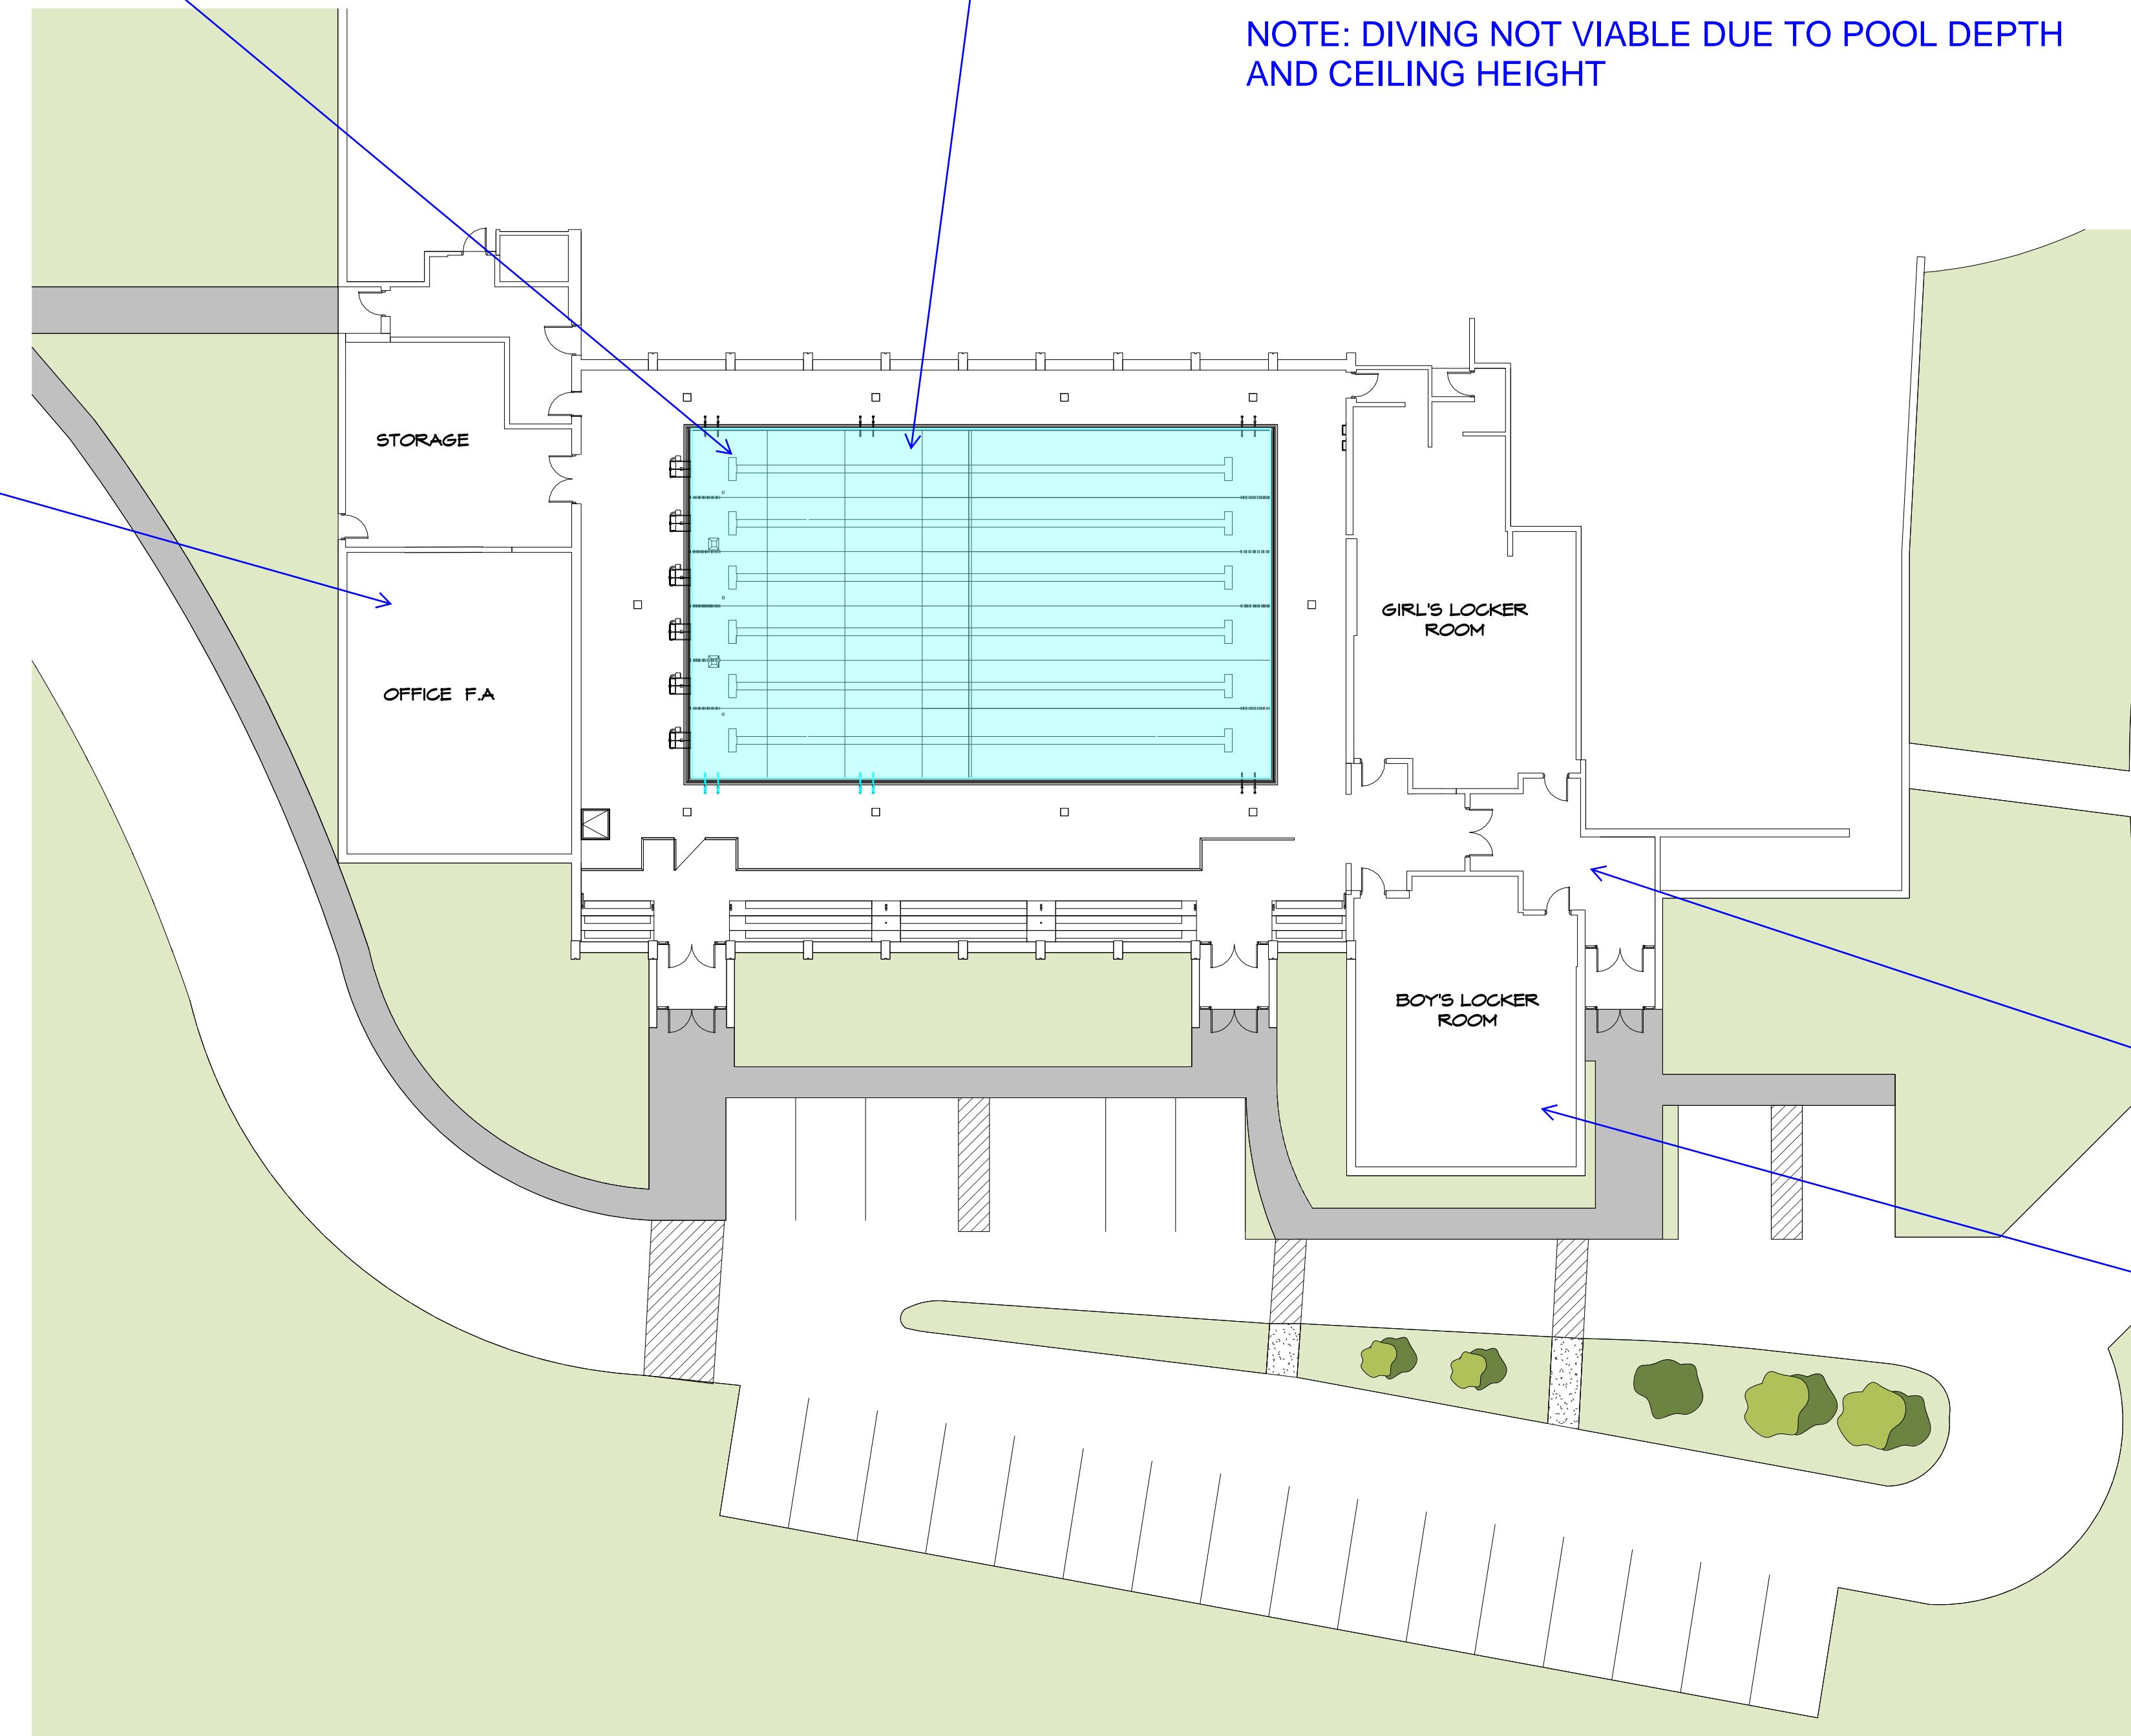
FLOOR PLAN OPTION 1 - NO DIVING - EXISTING POOL REFURBISHED

SWIMMING POOL OPTIONS INCLUDE:  
- 6 LANE 25y  
- REDUCE DEPTH TO MAX 5-FEET, OR LEAVE AT +- 10-FEET

ADDITION TO ACCOMMODATE COACHES/LIFEGUARD OFFICES, FIRST-AID AND DECK STORAGE

SWIMMER ENTRANCE, SEPARATE FROM SPECTATOR ENTRANCE

SMALL ADDITION TO LOCATE LOCKER ROOMS ON THE SHALLOW END OF POOL AND WITH IMPROVED CIRCULATION.

13. Conceptual Design Options: Two options were presented that represent a range of possibilities. The minimum scope of work to make a fully compliant facility which accommodates a 6-lane, 25-yard swimming pool with no diving as presented is Option 1. Option 2 represents an expanded pool to accommodate diving, as well as expanded program offering, including additional lanes. It was noted that within this option, pool configurations can include a lap pool with diving, combined with a separate warm water pool, a 25-yard stretch pool, or other combinations depending on pool program needs.

Option 1 has an estimated construction cost of \$6M with Project costs of \$7.6M. Option 2 has an estimated construction cost of \$13.5M with Project Cost of \$17M. These were described as Rough Order of Magnitude Costs, meaning they may vary +/-20% depending on a number of factors.

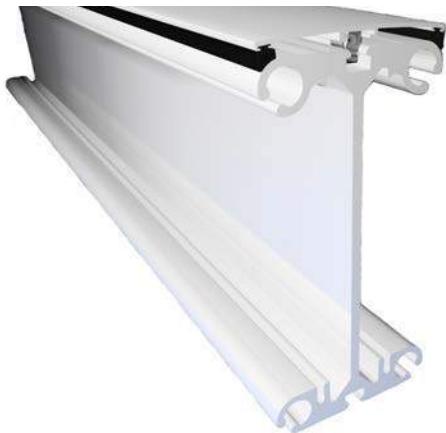
Aluminum Beam

Sprung's high quality, corrosion proof, aluminum substructure, encapsulated pool insulation, and mold and mildew resistant membranes are ideally suited for swimming pool environments.

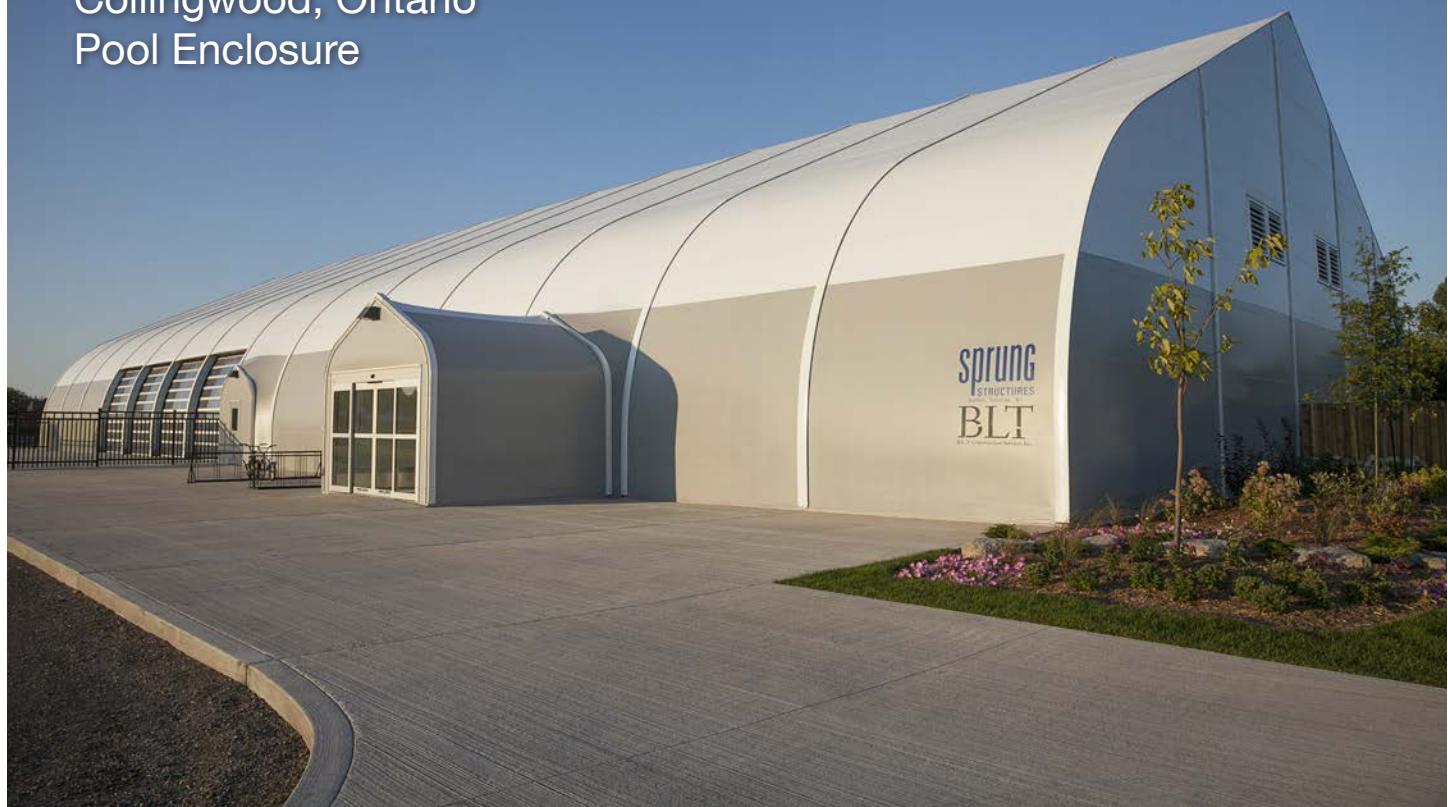
## Centennial Aquatic Centre

The outdoor pool in Collingwood Ontario was built in 1967, and in 2013, was enclosed with a new high-tech Sprung structure, allowing it to be used year-round. An additional accessible warm-water pool was also added to enhance the facility.

A 90' x 210' Sprung structure was erected in a 6 month timeframe and features a specially designed pool insulation system that performs extremely well in high humidity environments, while translucent daylight panels and sunshine doors add natural daylight to enhance the swimming experience.
