APPENDIX A
Area A Manhole Inspection Reports

Project Name: Trumbull 9/9 MANHOLE INSPECTION REPORTSubsystem Name/No. 5Manhole ID No. 5337Rating System (NASSCO)

Trumbull, CTPROJECT NO.: 12051 DDATE: 8/30/2011WEATHER: SunnyTIME: 3:16 pmINSPECTOR: mm, nke

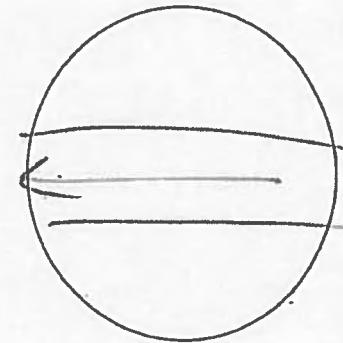
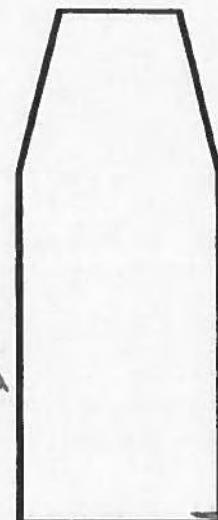
COVER: Y/N Est. I/I JOINTS: Y/N Est. I/I WALLFRAME: X/N Est. I/I INVERTS: Y/N Est. I/I tableWALLS: Y/N Est. I/I TABLES: Y/N Est. I/I 0-19"TOTAL ESTIMATED I/I (GPM): 119 p/mCORROSION PROBLEMS? Y/NCOMMENTS (REQUIRED): MINOR Infiltration

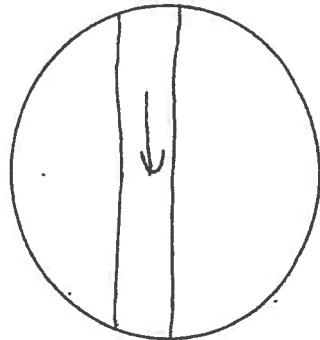
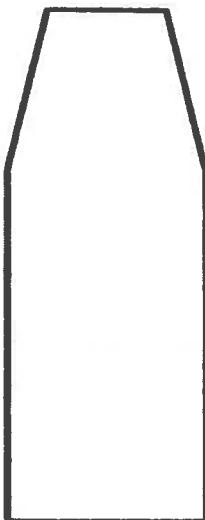
COMMENTS (REQUIRED): Bricks falling apart. Riser
is leaking steadily.

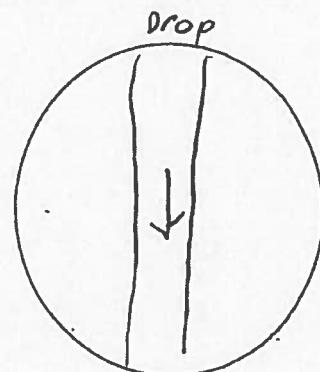
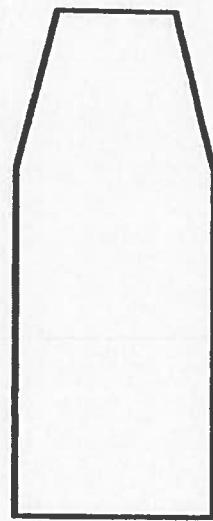
There is a loose
build into the RH.

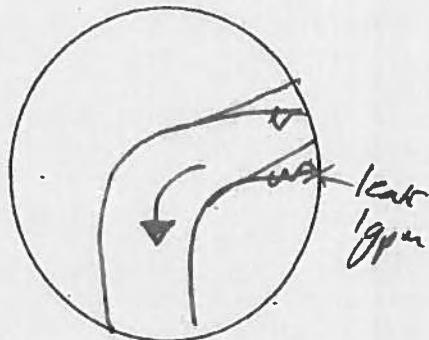
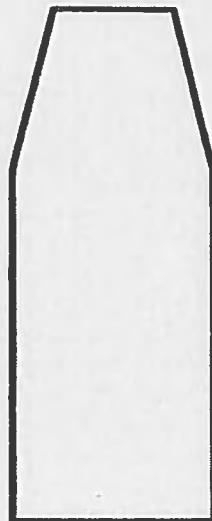
COMMENTS (REQUIRED): leak on wall (1gpm) right above
table

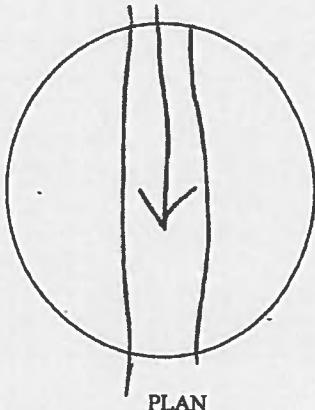
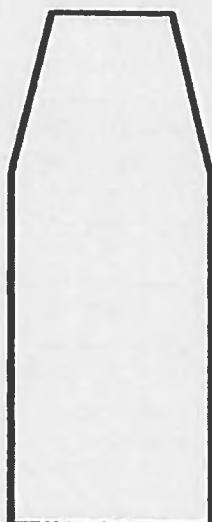
COVER: Y/N Est. I/I JOINTS: Y/N Est. I/I FRAME: Y/N Est. I/I INVERTS: Y/N Est. I/I WALLS: Y/N Est. I/I 2 3 6 pm TABLES: Y/N Est. I/I TOTAL ESTIMATED I/I (GPM): 2-3 pmCORROSION PROBLEMS? Y/NCOMMENTS (REQUIRED): Behind manhole SECTION stairs corr.

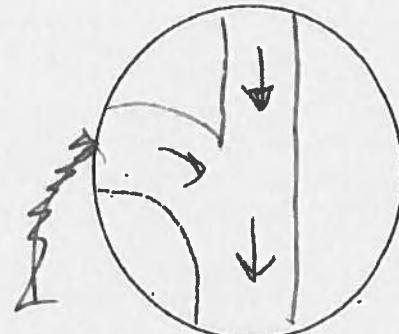
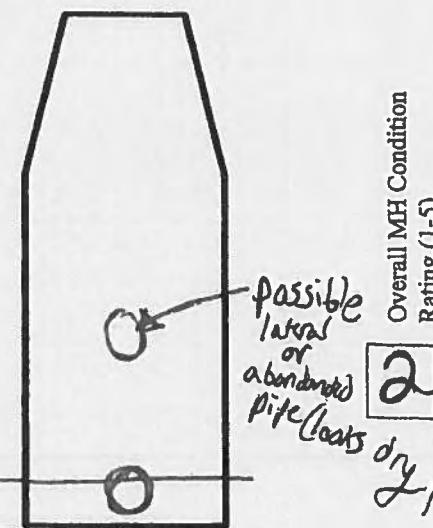
COMMENTS (REQUIRED): Not C joint

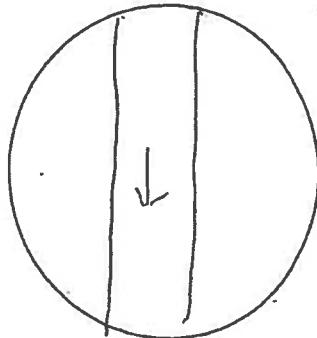
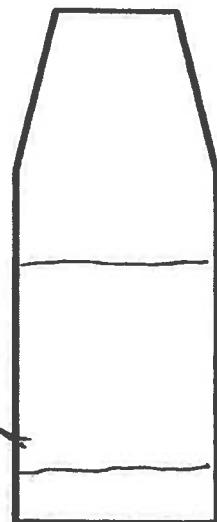
COMMENTS (REQUIRED): Leaking at bottom near the table SECTION

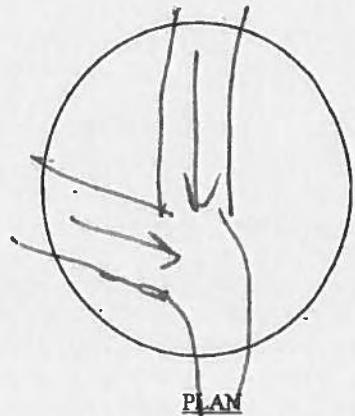
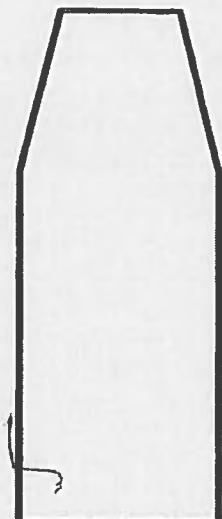
COVER: Y/N Est. I/I JOINTS: Y/N Est. I/I
FRAME: Y/N Est. I/I INVERTS: Y/N Est. I/I 19pm
WALLS: Y/N Est. I/I TABLES: Y/N Est. I/I 1-2TOTAL ESTIMATED I/I (GPM): 2-3CORROSION PROBLEMS? Y/NCOMMENTS (REQUIRED): Minor infiltration SECTION

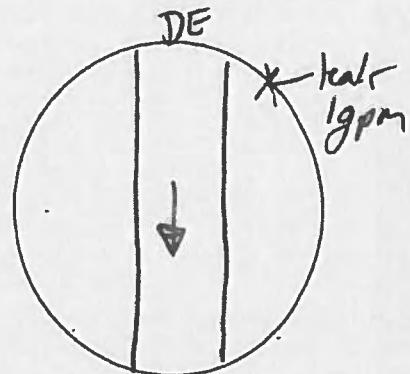
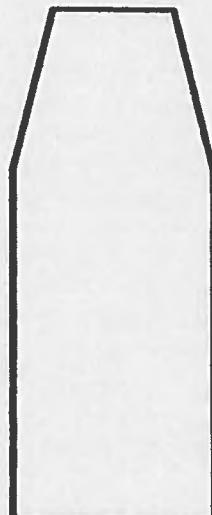
COMMENTS (REQUIRED): 1 leak @ 1 gpm above table SECTION

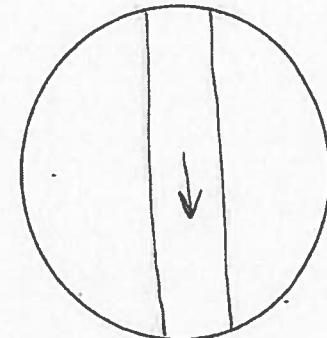
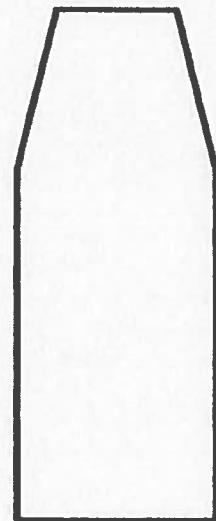
COMMENTS (REQUIRED): INVERT WAS CLOSED

2

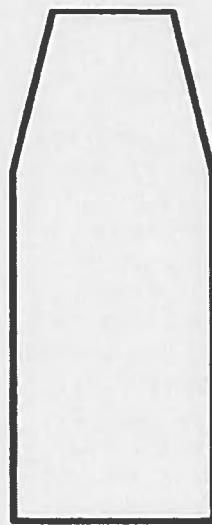
COMMENTS (REQUIRED): LEAKING AT TABLE CONNECTING
TO THE WALL. EVIDENCE OF LEAKAGE AT EGRESS. SECTION

3

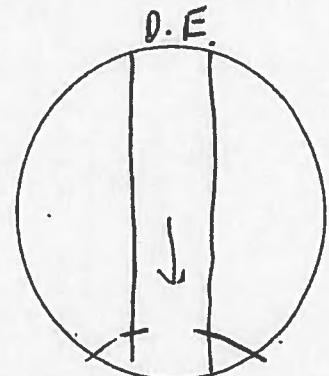
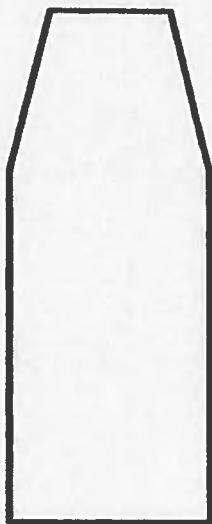
*Leaking PLAN
in invert*

3

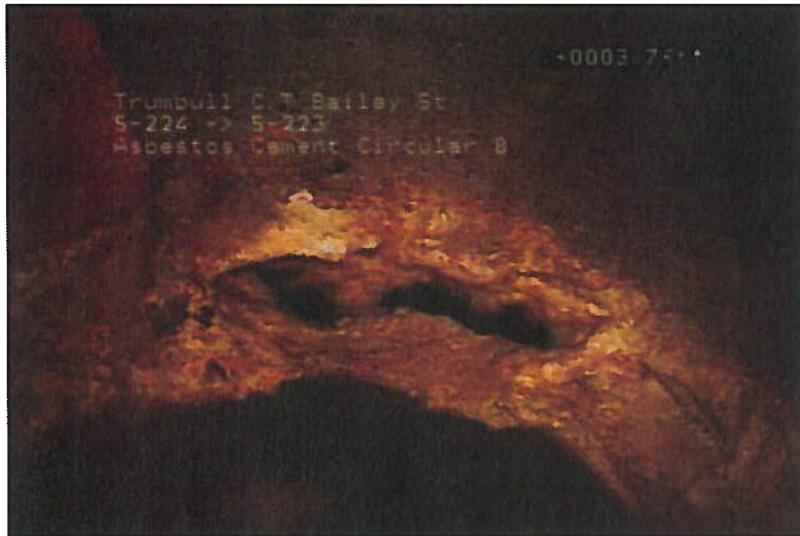
Section No :
235

Photo: 56_57_338_A.JPG, VCR No.: disc #7
0.1FT, Hole Soil Visible, from 10 to 12 o'clock, within 8 inches of joint:
YES

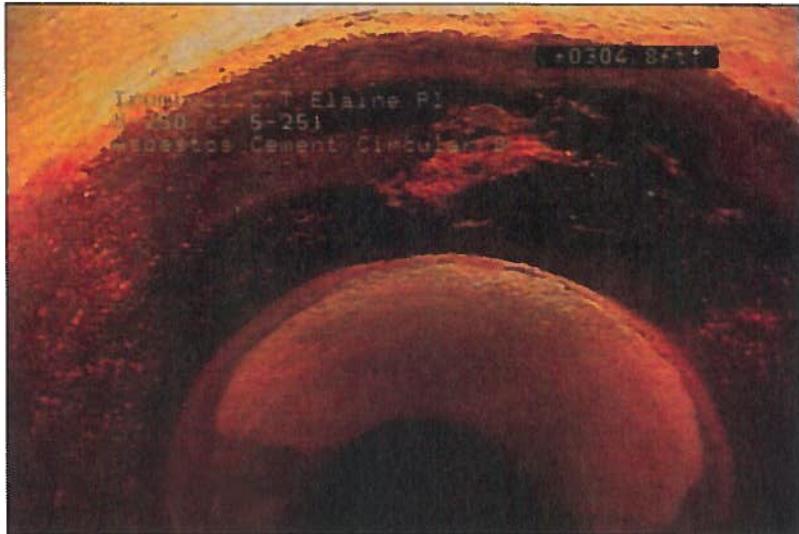
Section No :
264

Photo: 118_119_768_A.JPG, VCR No.: disc #13
 304.8FT, Deposits Attached Encrustation, 5 % of Cross Sectional Area, From 12 to 12 o'clock, within 8 inches of joint: YES

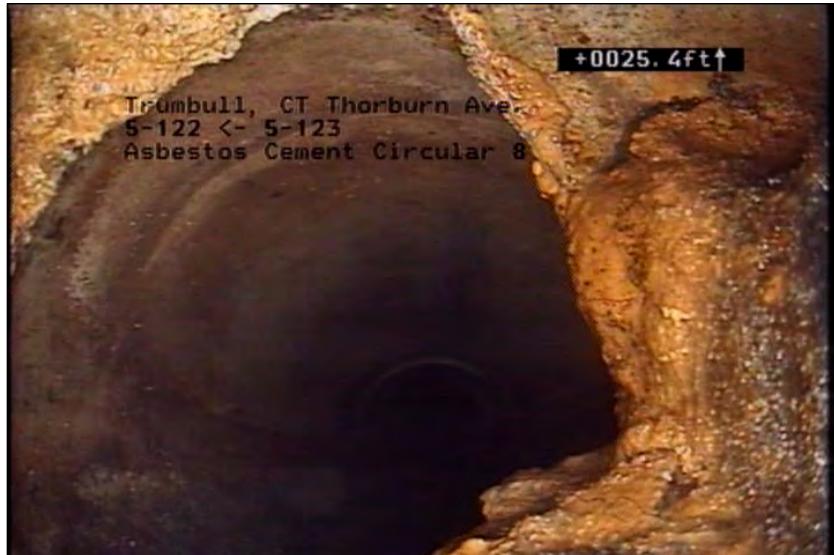
Section No :
131

Photo: 11_12_86_A.jpg, VCR No.: Tape 1
25.4FT, Deposits Attached Encrustation, 30 % of Cross Sectional
Area, At 02 o'clock, Within 8 inches of joint: NO

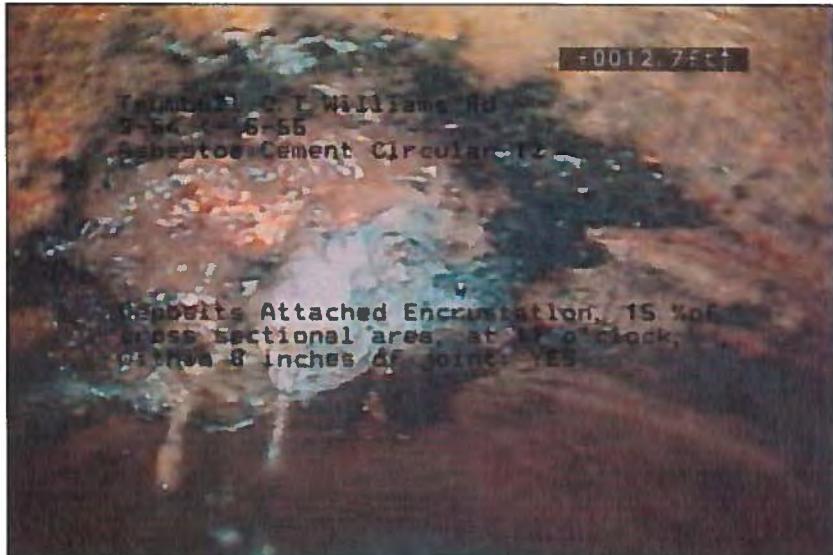
Section No :
60

Photo: 220_221_1222_A.JPG, VCR No.: disc #21
12.7FT, Deposits Attached Encrustation, 15 % of Cross Sectional Area, at 11 o'clock, within 8 inches of joint: YES

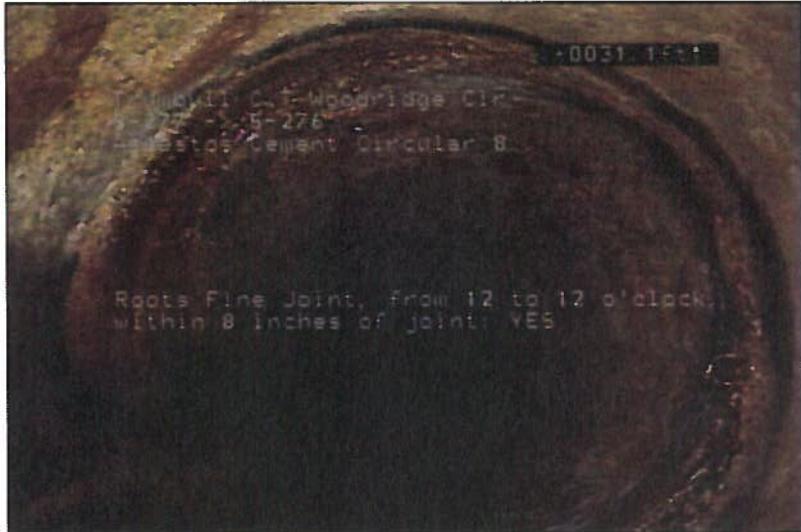
Section No :
289

Photo: 84_85_541_A.JPG, VCR No.: disc #10
31.1FT, Roots Fine Joint, from 12 to 12 o'clock, within 8 inches of joint:
YES

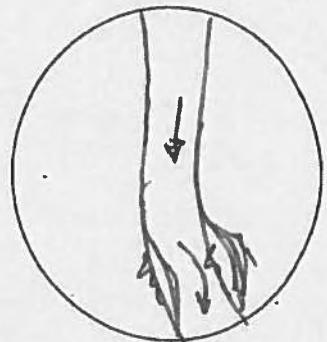
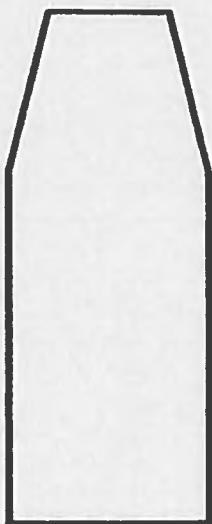
COMMENTS (REQUIRED): loss of flow

3

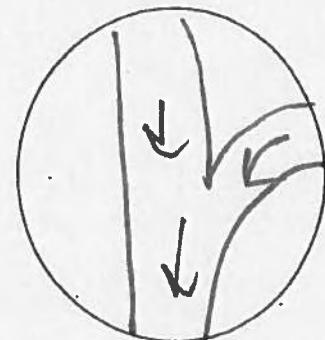
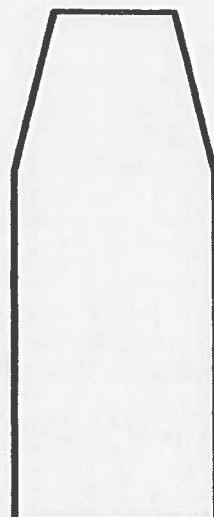
COMMENTS (REQUIRED): Seepage along table

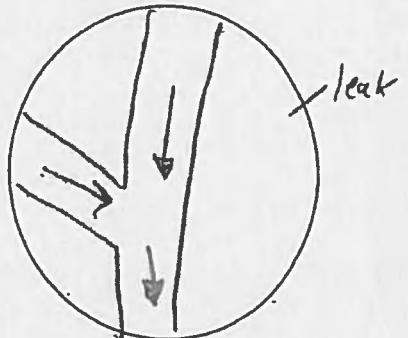
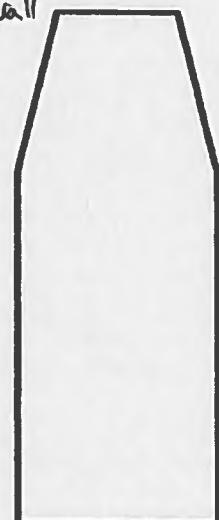
COMMENTS (REQUIRED): *actively leaking* *hole in wall (3-sym) → ~1/4" hole SECTION*

a bottom joint is actively seeping all the way around joint

4

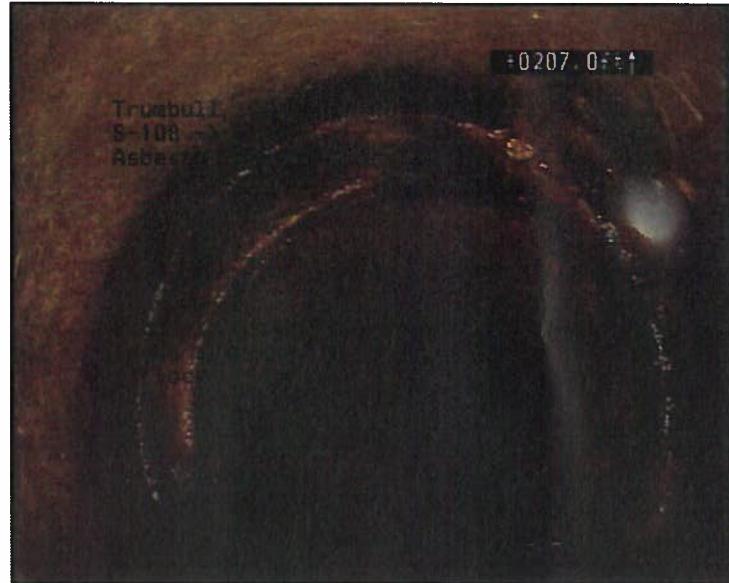
Section No :
113

Photo: 31_32_262_A.JPG, VCR No.: Tape 1
207FT, Deposits Attached Encrustation, 5 % of Cross Sectional Area,
From 12 to 12 o'clock, Within 8 inches of joint: YES

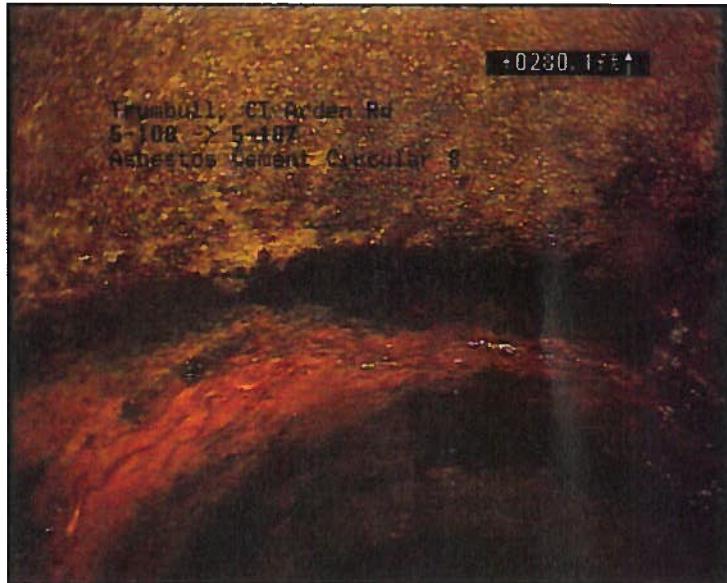
Photo: 31_32_266_A.JPG, VCR No.: Tape 1
280FT, Deposits Attached Encrustation, 5 % of Cross Sectional Area,
At 10 o'clock, Within 8 inches of joint: YES

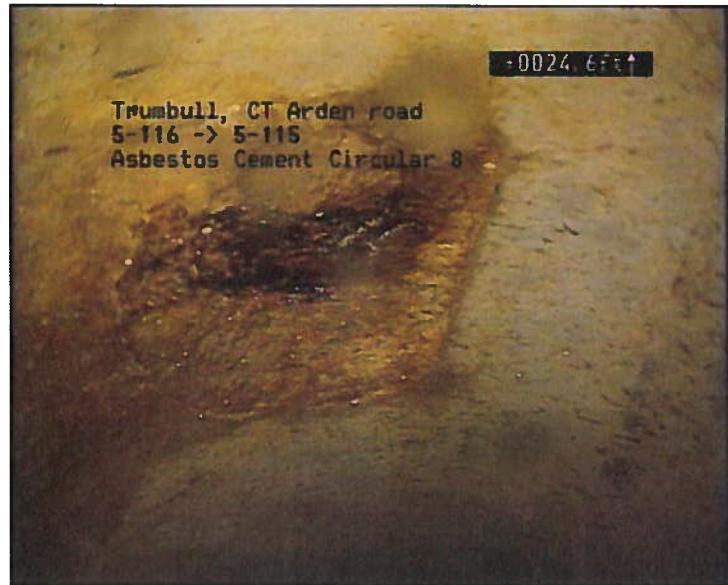
Section No :
122

Photo: 24_25_193_A.JPG, VCR No.: Tape 1
24.6FT, Hole Soil Visible, at 12 o'clock, within 8 inches of joint: NO

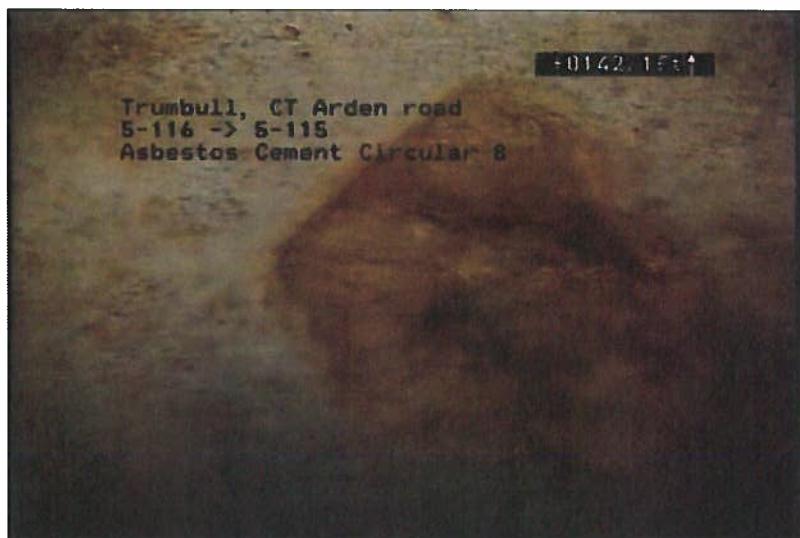
Photo: 24_25_196_A.jpg, VCR No.: Tape 1
142.1FT, Hole, at 12 o'clock, within 8 inches of joint: NO

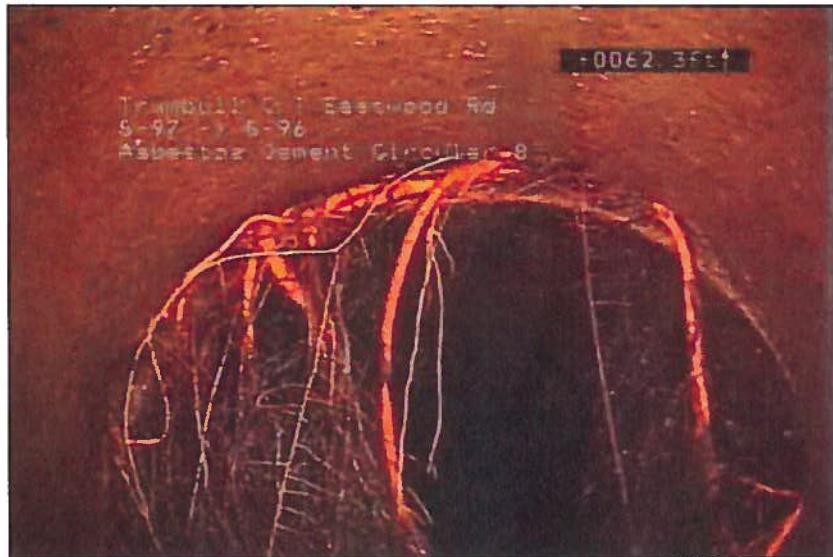
Section No :
102

Photo: 96_97_677_A.jpg, VCR No.: disc #6
62.3FT, Roots Medium Joint, from 12 to 12 o'clock, 10 %, within 8
inches of joint: YES

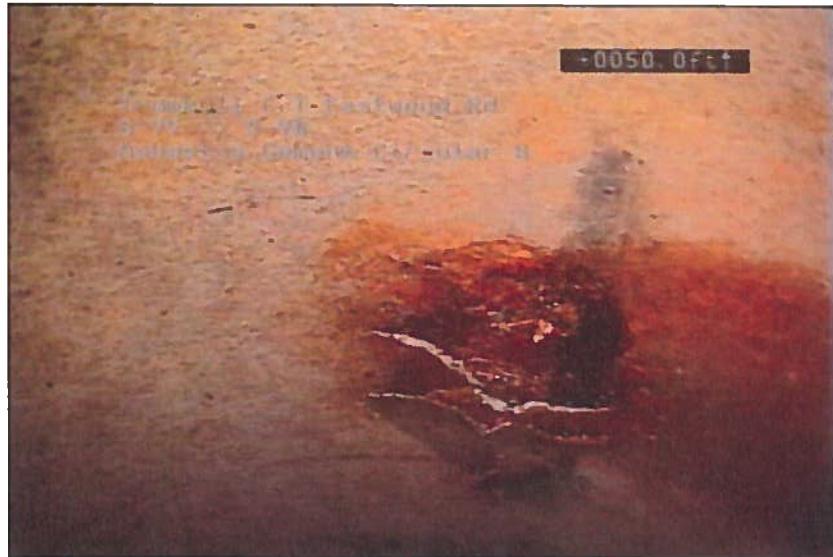
Section No :
104

Photo: 46_47_270_A.JPG, VCR No.: disc #6
50FT, Hole, at 01 o'clock, within 8 inches of joint: NO

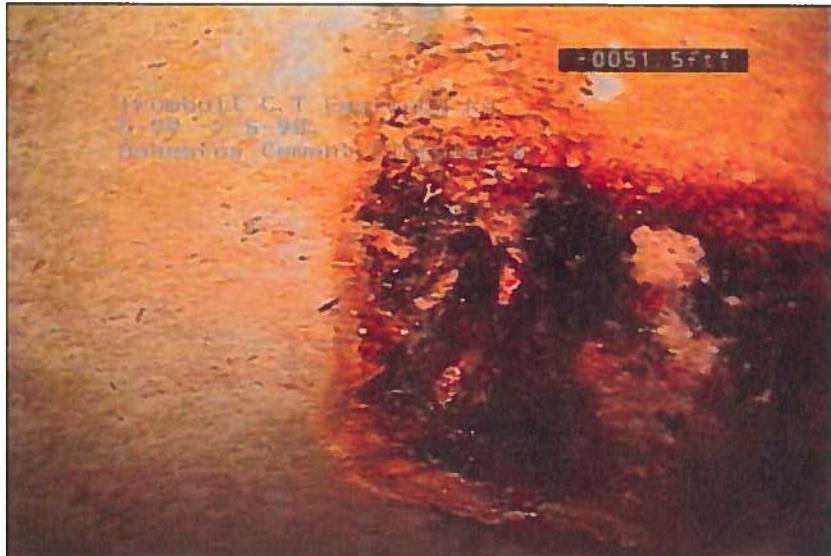
Section No :
104

Photo: 46_47_272_A.JPG, VCR No.: disc #6
51.5FT, Hole Void Visible, at 02 o'clock, within 8 inches of joint: NO

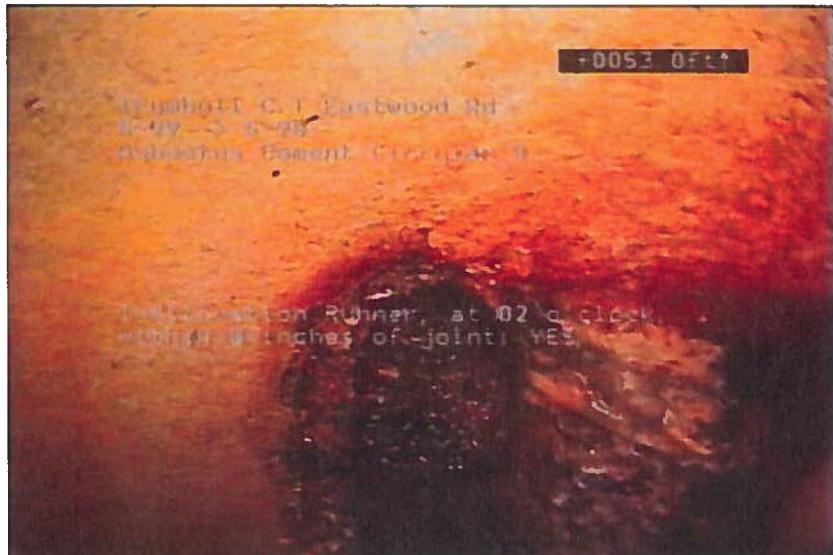
Section No :
104

Photo: 46_47_274_A.JPG, VCR No.: disc #6
53FT, Hole Void Visible, at 02 o'clock, within 8 inches of joint: YES

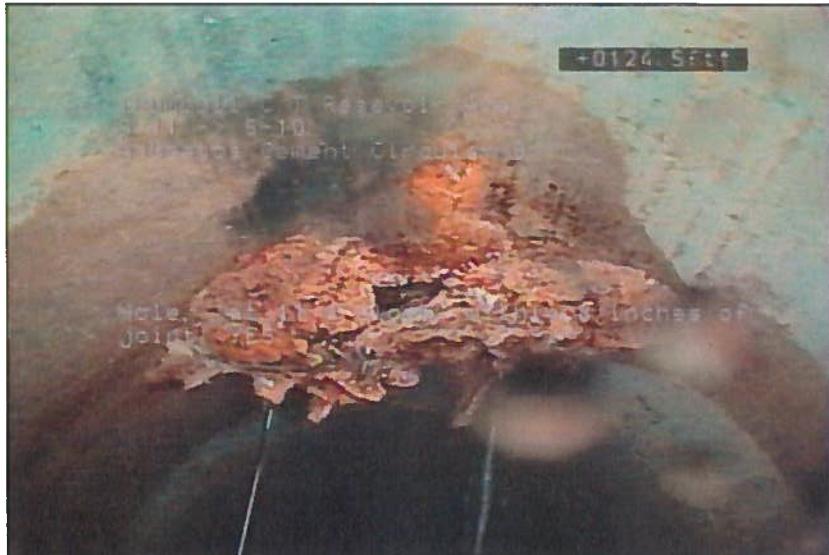
Section No :
11

Photo: 179_180_1054_A.JPG, VCR No.: disc #18
124.5FT, Hole, at 11 o'clock, within 8 inches of joint: YES

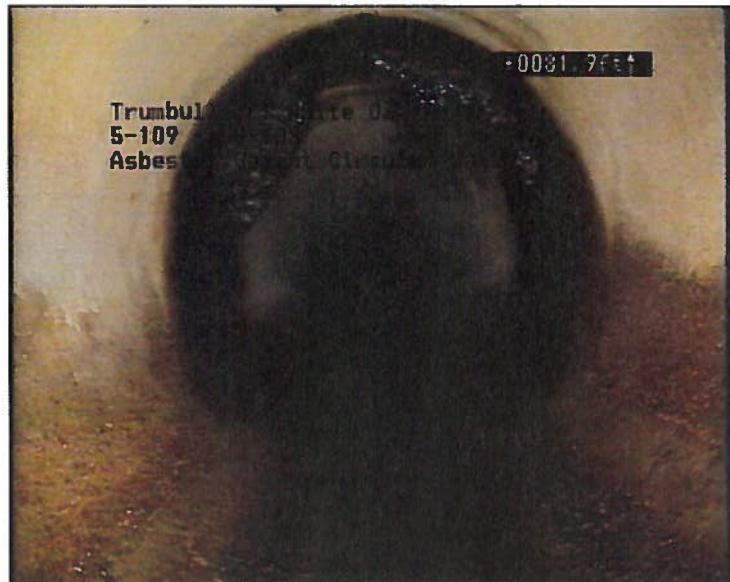
Section No :
114

81.90	DAE	Deposits Attached Encrustation, 10 % of Cross Sectional Area, From 12 to 11 o'clock, Within 8 inches of joint: YES	30_31_252_A.JPG
	81.90	ID	Infiltration Dripper, at 01 o'clock, within 8 inches of joint: YES

Photo: 30_31_252_A.JPG, VCR No.: Tape 1
81.9FT, Deposits Attached Encrustation, 10 % of Cross Sectional
Area, From 12 to 11 o'clock, Within 8 inches of joint: YES

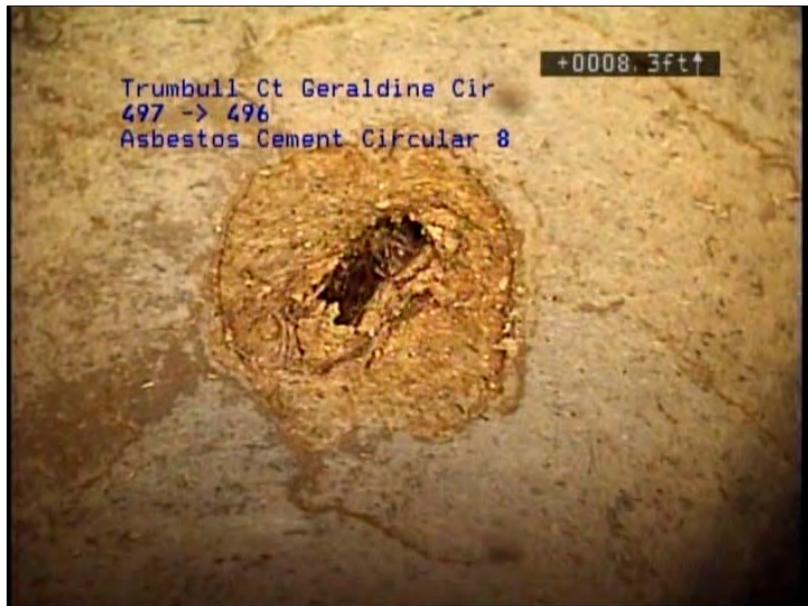
Section No :
50

Photo: 213_213_1121_A.jpg, VCR No.: Disc 16
8.3FT, Hole Soil Visible, at 12 o'clock, within 8 inches of joint: NO

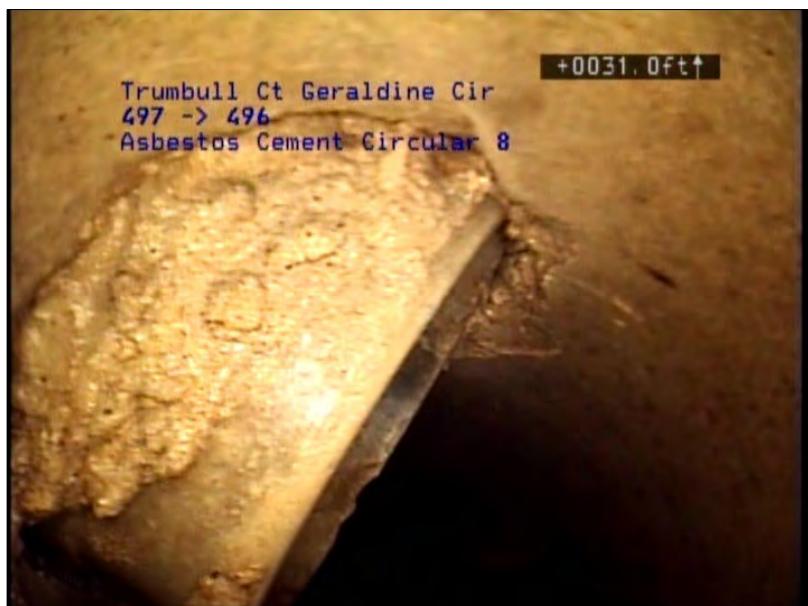
Photo: 213_213_1125_A.jpg, VCR No.: Disc 16
31FT, Survey Abandoned

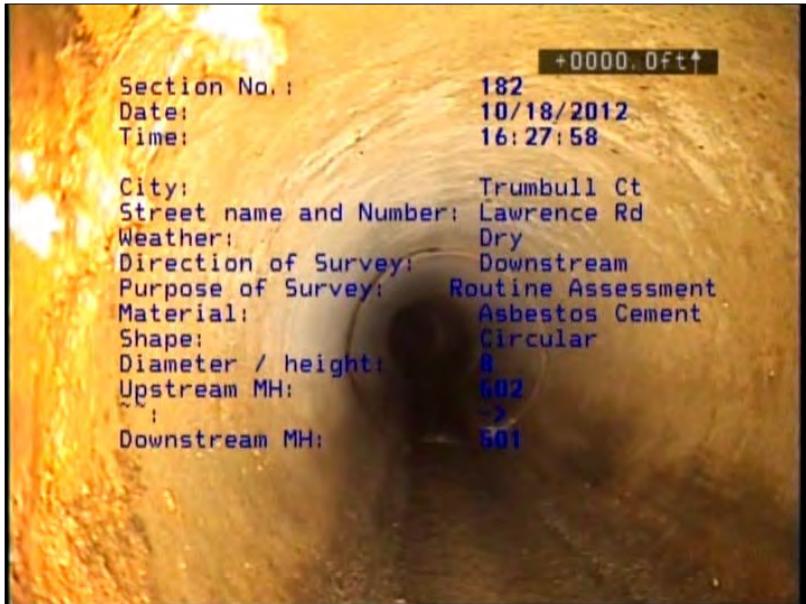
Section No :
55

Photo: 245_245_2873_A.jpg, VCR No.: Disc 21
1FT, Hole, at 10 o'clock, within 8 inches of joint: YES

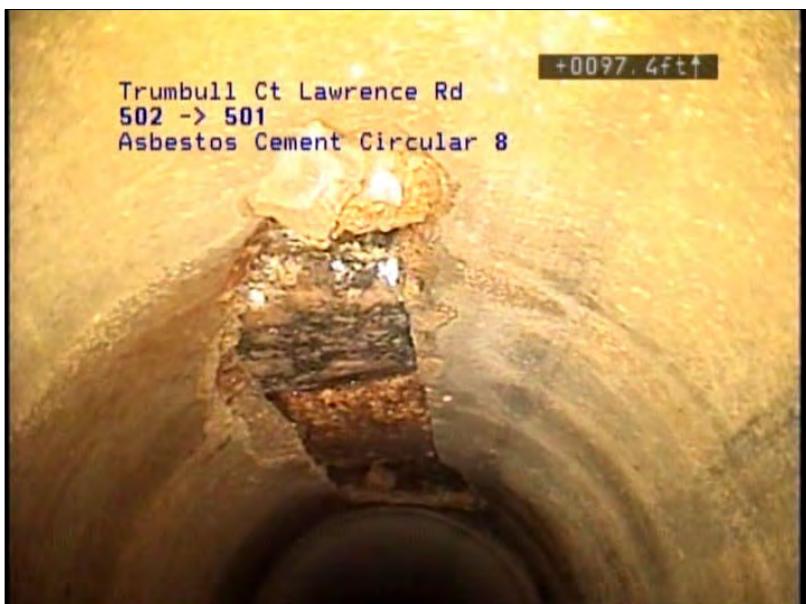
Photo: 245_245_1286_A.jpg, VCR No.: Disc 21
97.4FT, Hole Void Visible, from 11 to 01 o'clock, within 8 inches of joint: YES

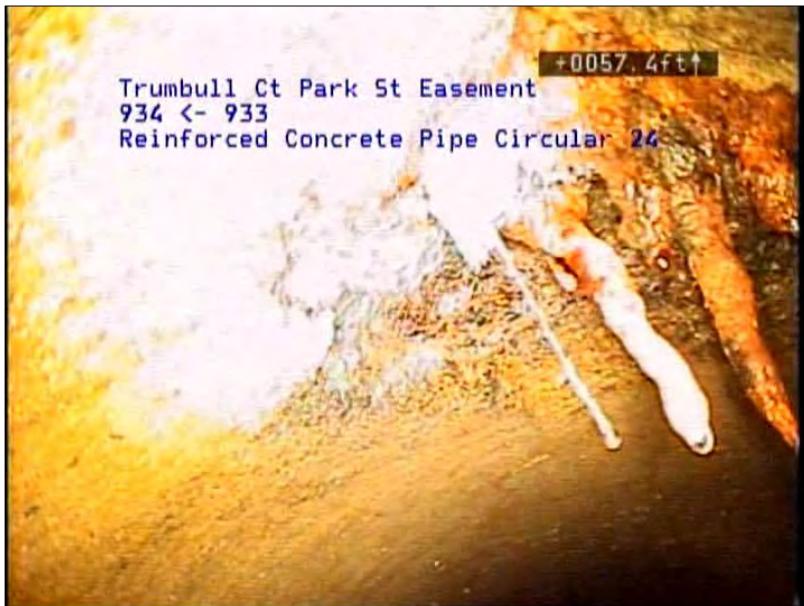
1:154	Position	Code	Observation	Photo			
	0.00	AMH	Downstream Manhole, Survey Begins / MH 934				
	0.00	MWL	Water Level, 5 % Of Cross Sectional Area				
57.30	DAE	Deposits Attached Encrustation, 30 % Of Cross Sectional Area, From 02 to 06 o'clock, Wthin 8 inches of joint: NO					
57.40	MSA	Survey Abandoned / Ragging From Lateral. Complete's Inspection.	485_485_2456_A.jpg				
QSR	QMR	SPR	MPR	OPR	SPRI	MPRI	OPRI
0000	1121	6	6	6	6	3	3

Photo: 485_485_2456_A.jpg, VCR No.: 43
57.4FT, Survey Abandoned

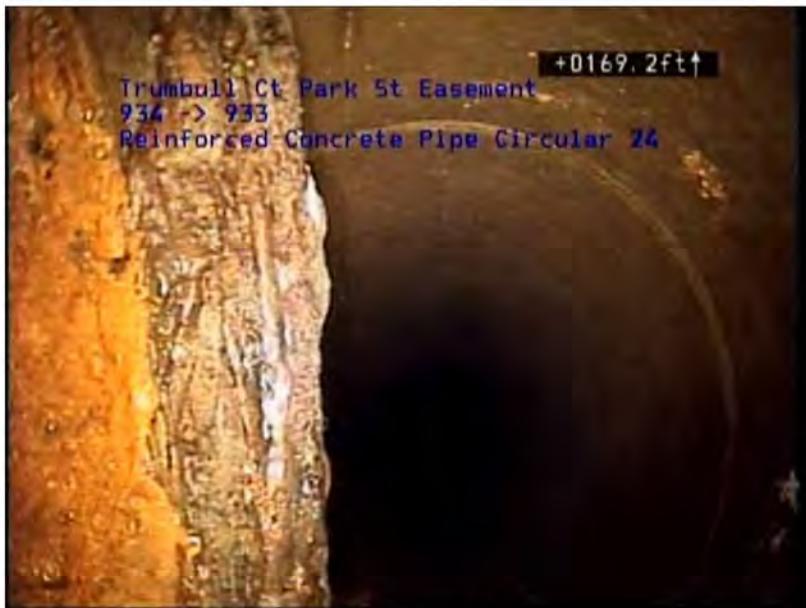
169.20	MSA	Survey Abandoned / Roots With Deposites Attached.	484_484_2454_A.jpg
QSR	QMR	SPR	MPR	OPR
0000	4132	0	16	16
SPRI	MPRI	OPRI		
0	2.67	2.67

Photo: 484_484_2454_A.jpg, VCR No.: 43
169.2FT, Survey Abandoned

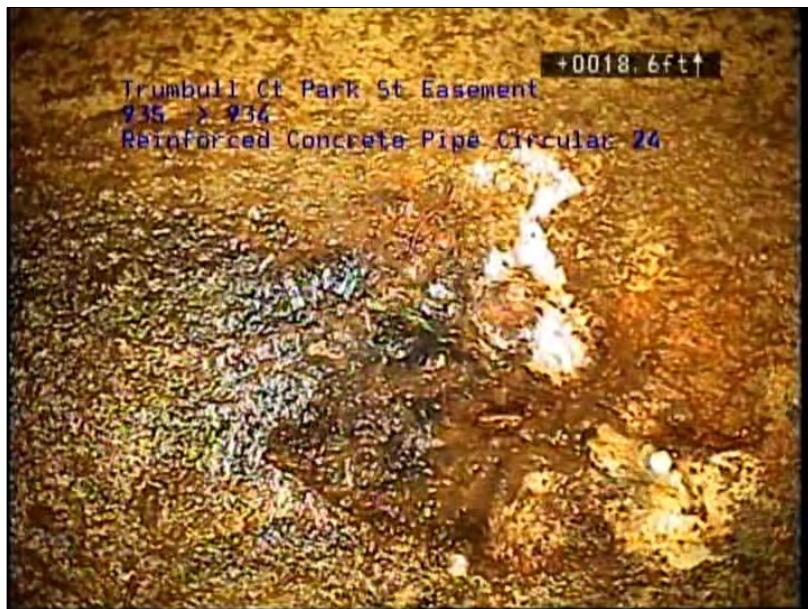
Photo: 483_483_2441_A.jpg, VCR No.: 43
18.6FT, Hole Soil Visible, at 12 o'clock, within 8 inches of joint: NO

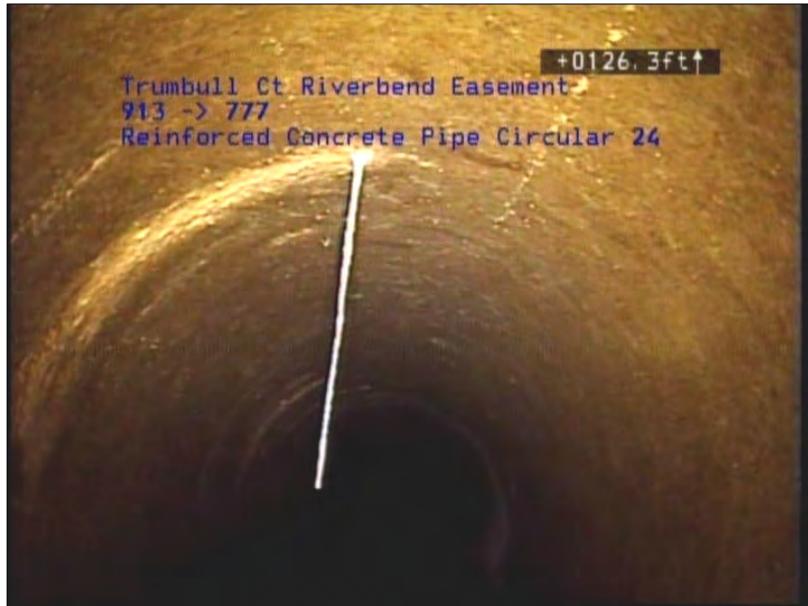
Photo: 502_502_2532_A.jpg, VCR No.: 45
126.3FT, General Observation
